## Mock Inspection Report

14432 Blue Lake Rd, Panama City, FL 32409-4665.

Dec 2, 2024

This is a mock inspection report to demonstrate that the inspector has performed an inspection according to the InterNACHI® Standards of Practice.

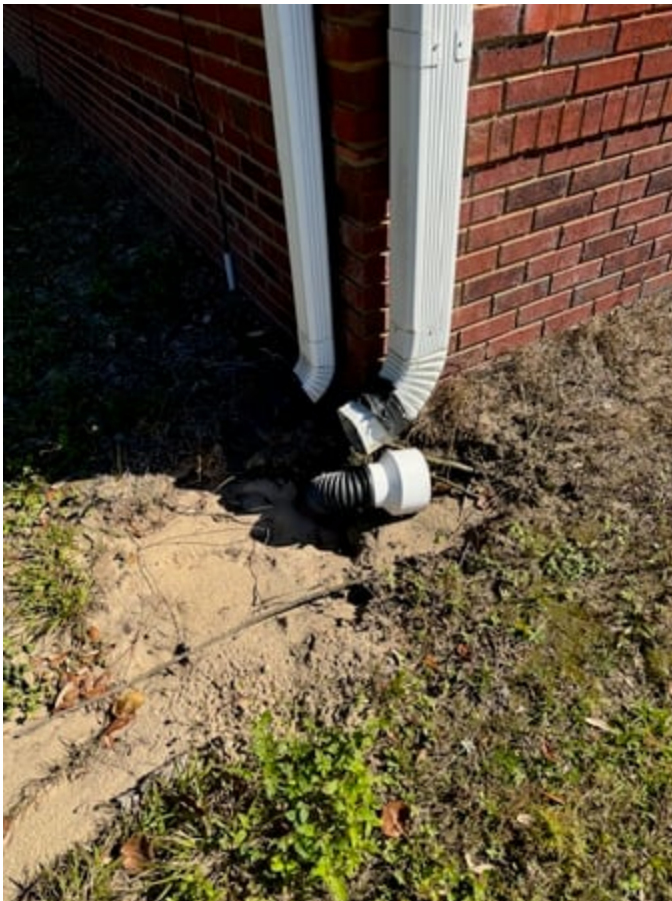
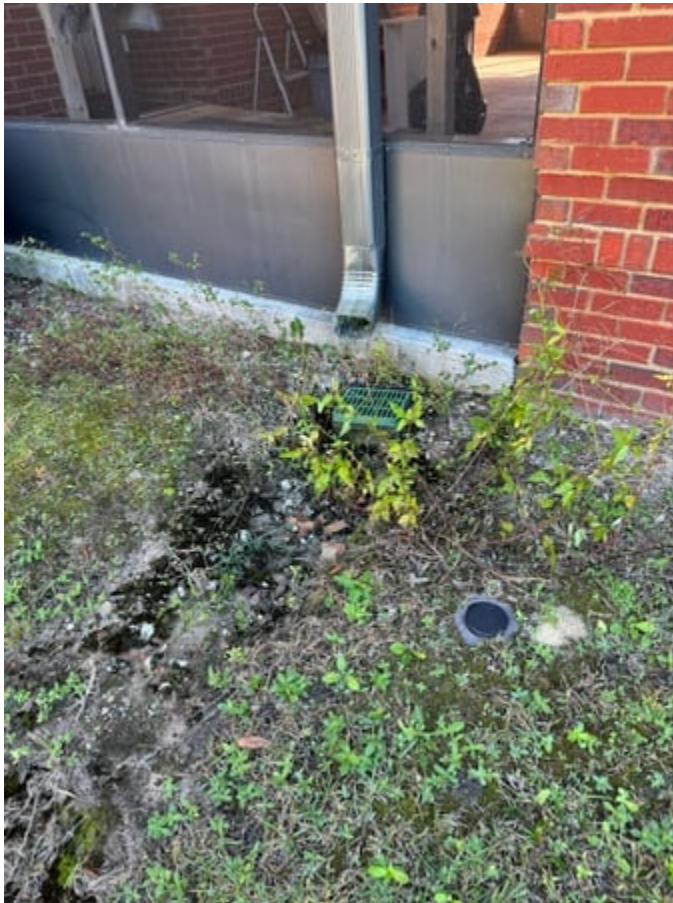
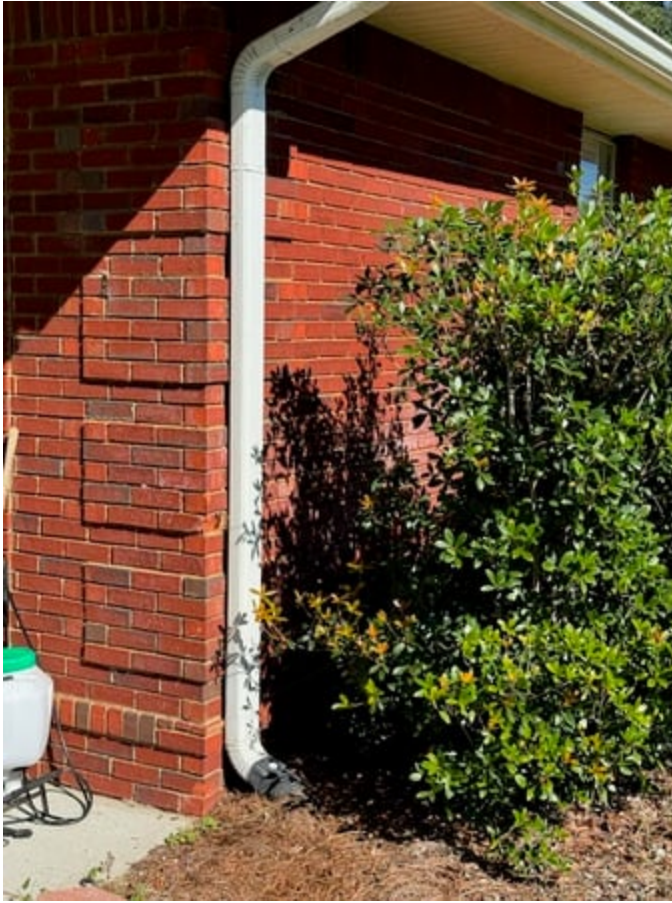
## Downspouts

Minor Defect

Downspouts disconnected at drainage point(s). Recommend immediate repair to ensure proper water drainage away from the foundation.

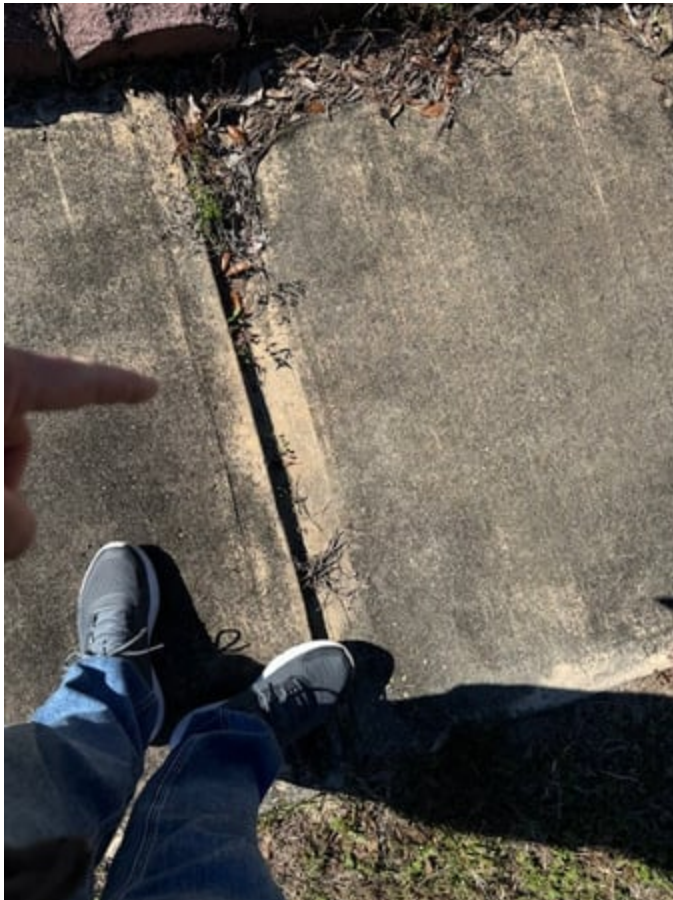
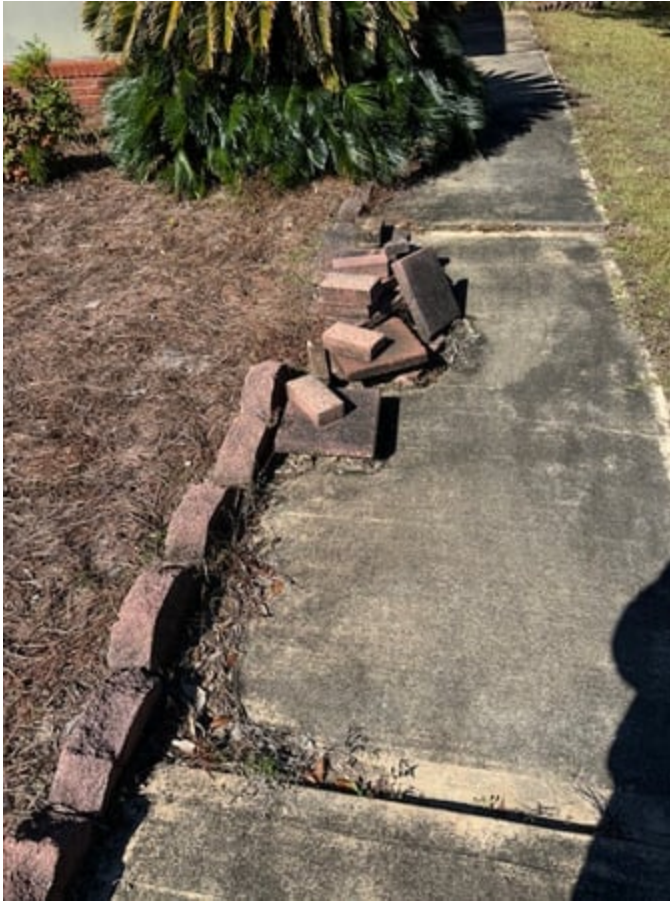
## Adjacent Walkways and Driveways

Minor Defect

No cracks were observed in the concrete parking pad. Uneven concrete near the back of the house walkway poses a tripping hazard, and loose bricks encumber the walking path—recommendation for immediate repair to avoid further separation and cracking the concrete pad from underneath.

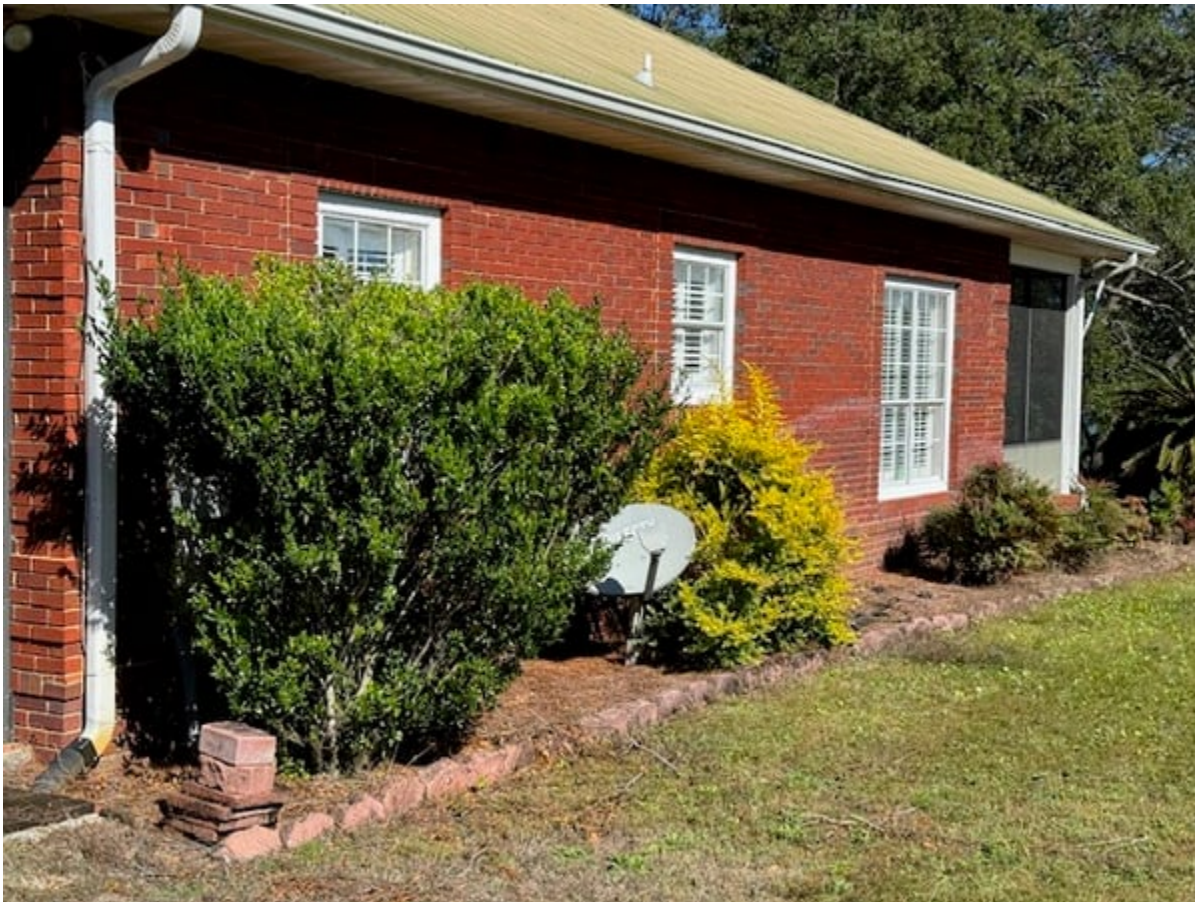
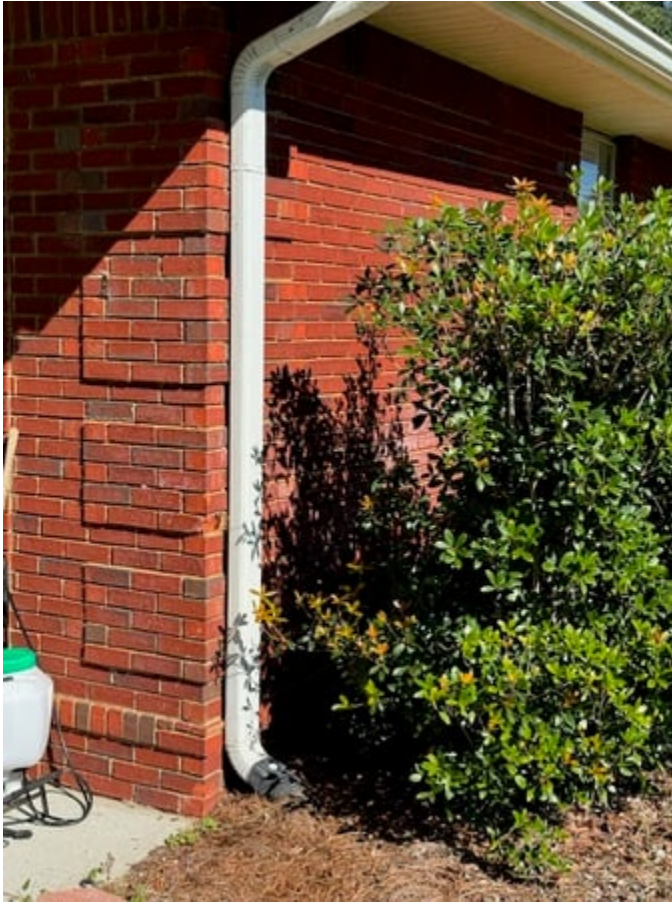
**Minor Defect**

Vegetation is growing up against the exterior walls. Recommend trimming to reduce water exposure

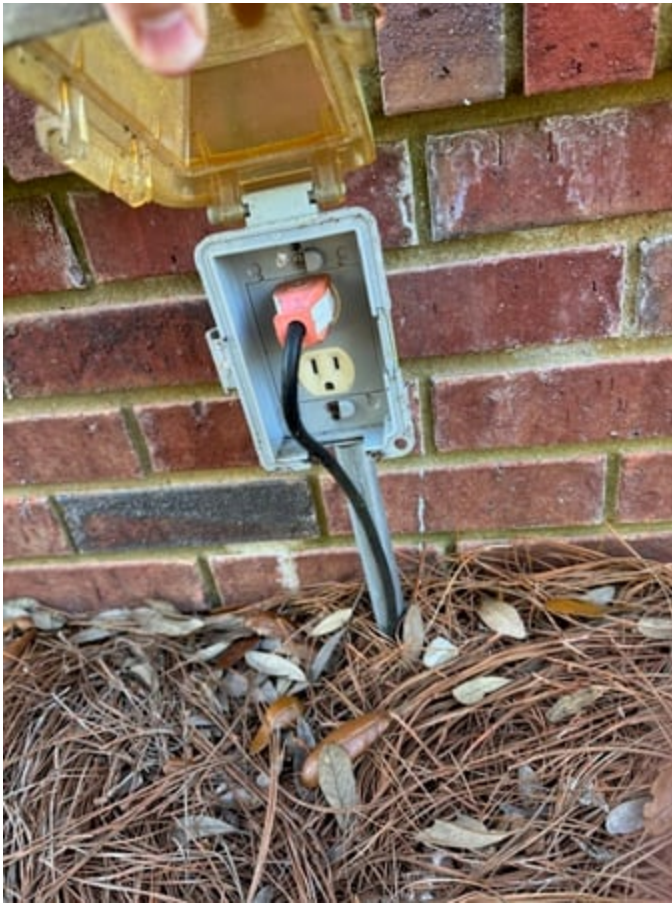
### Ground-Fault Circuit Interrupter Receptacles and Circuit Breakers

**Minor Defect**

The GFCI outlet is not present on the outside back walkway. I recommend installing one for over-current protection.
