Inspection report for the property at , Bremerton, WA

This report is prepared exclusively for **Joe Smith** Inspected On: **06-05-2023**

Company Information Clearview Property Inspections 678-488-9479 jeff@clearviewproperty.biz www.clearviewproperty.biz Published Report

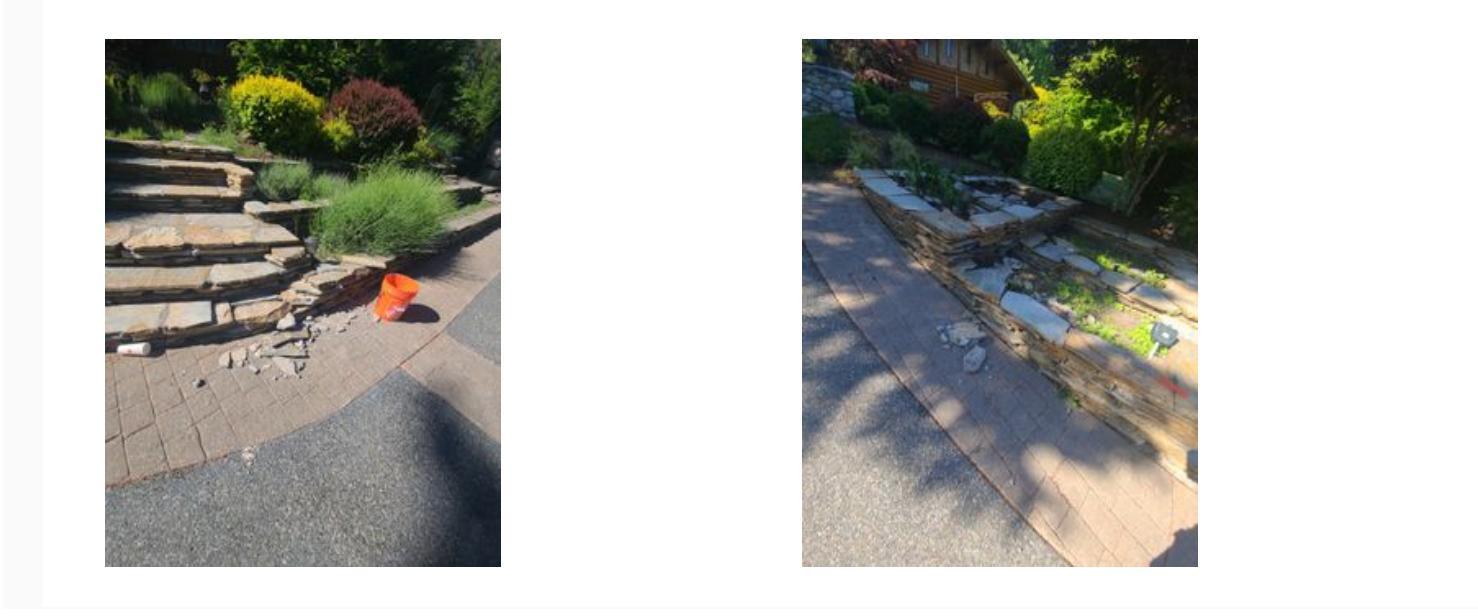
A number of small repairs are underway to the stone retaining wall. Complete repairs as needed.

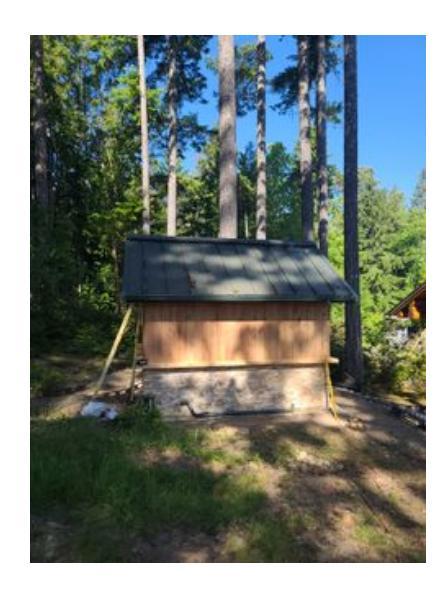
WELL HOUSE

Carpentry repairs window to the exterior of the wellhouse. Complete carpentry repairs prior to listing.

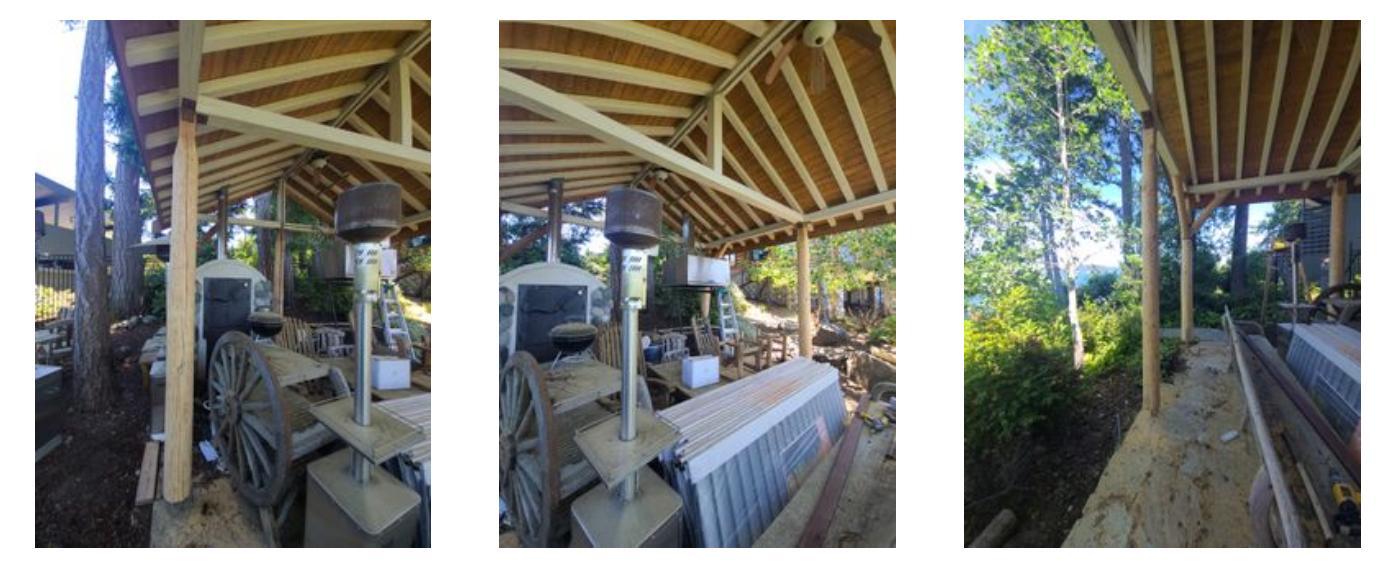
GRILLING OUTBUILDING

A weathered in building was noted at the NW corer of the property. This looks set up as an outdoor cooking area. The equipment here is beyond the scope of this inspection. I would disclose to a buyer more information about these systems. Also, it seems that posts are in the midst of being refinished. Complete refinishing here as needed.

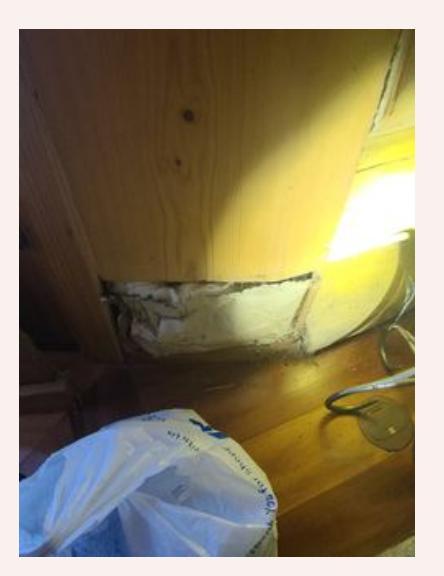
A dead carpenter ant was noted inside in this area.

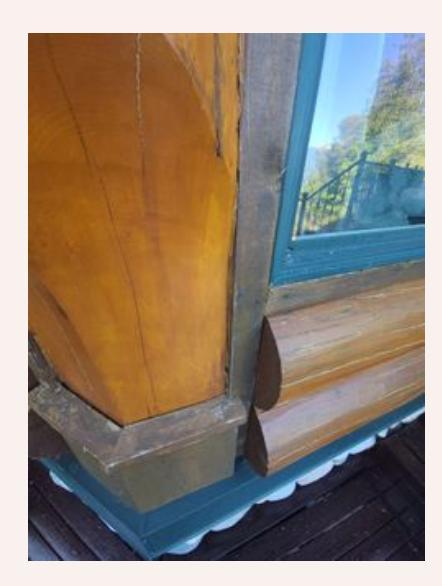
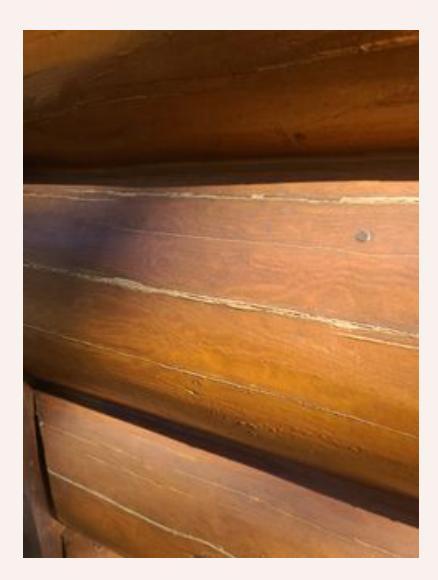
Exterior finishes are deteriorating in some exposed locations. This shows the water side deck door

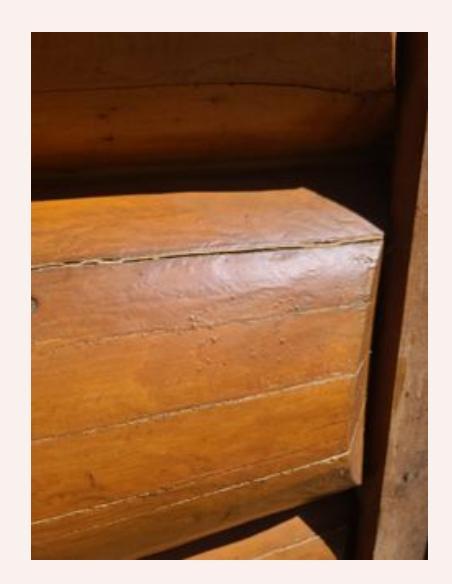
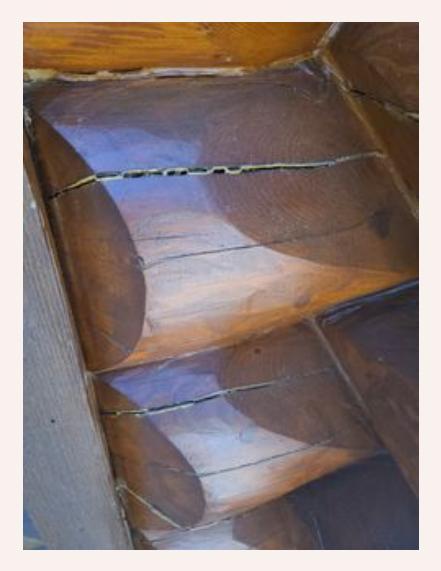
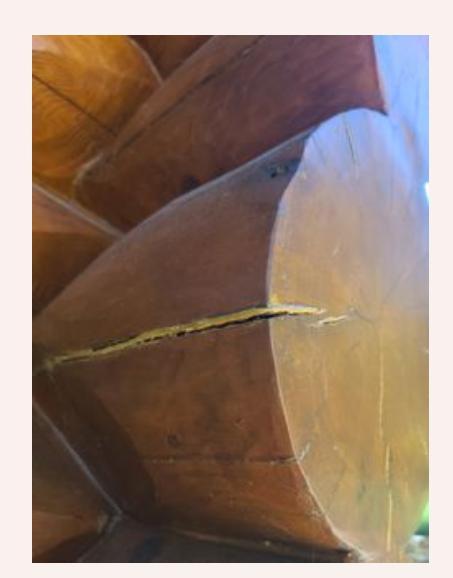
Minor cracks are developing in the sealant used to seal checks in sun-exposed logs - re-sealing will be needed soon.

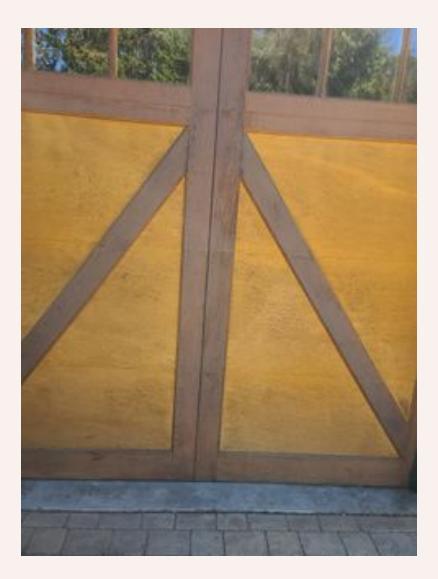
Stain failure noted in several places

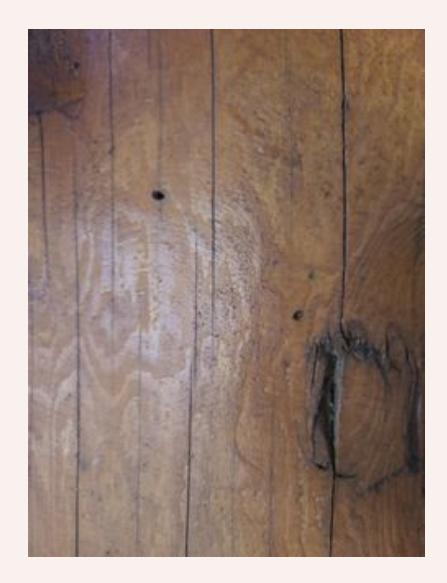
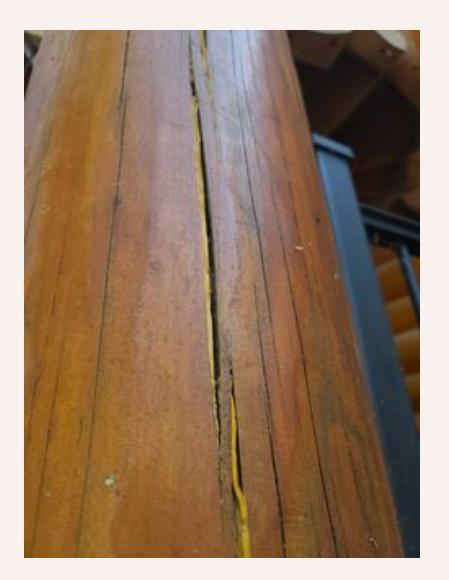
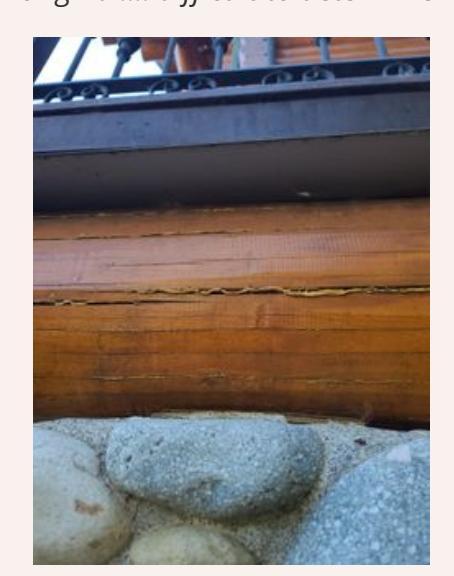
Exit holes noted in the logs on the south stairs and the entry posts. These may be old or even original.... difficult to determine

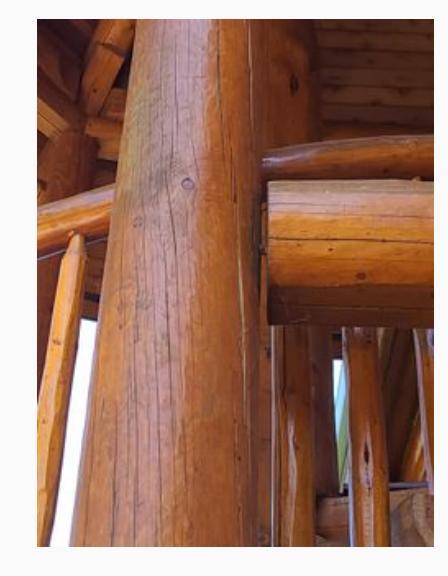
Exit holes noted in the large logs at the entry

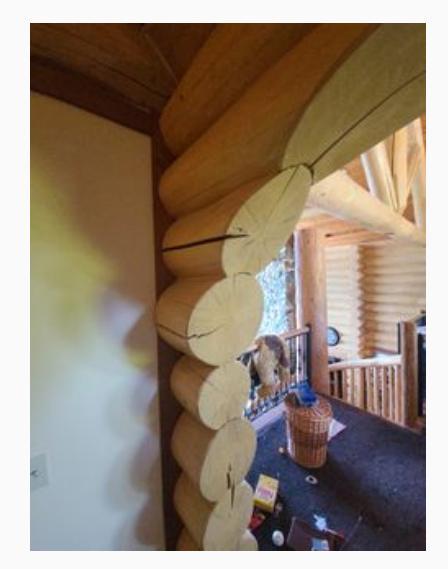
Cracks like these are known as checking - this is typical in log homes

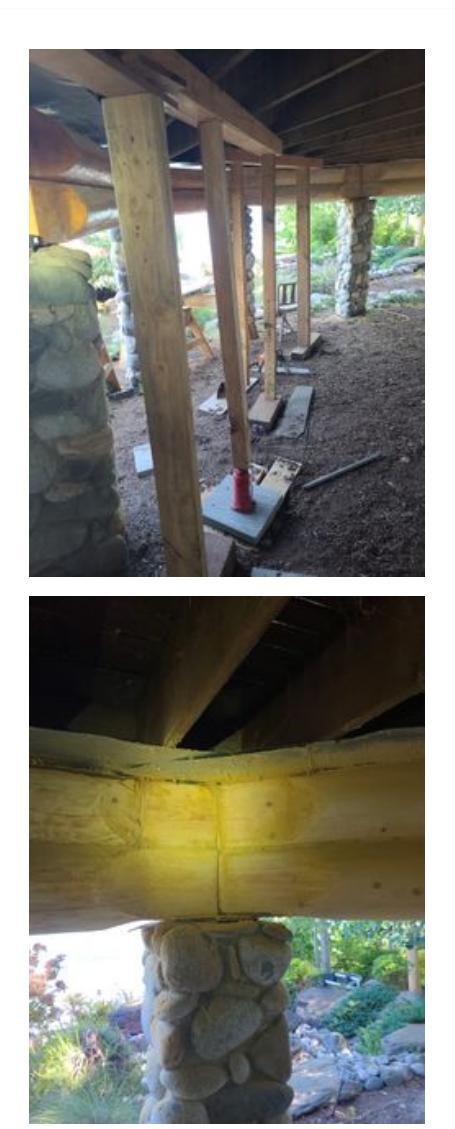
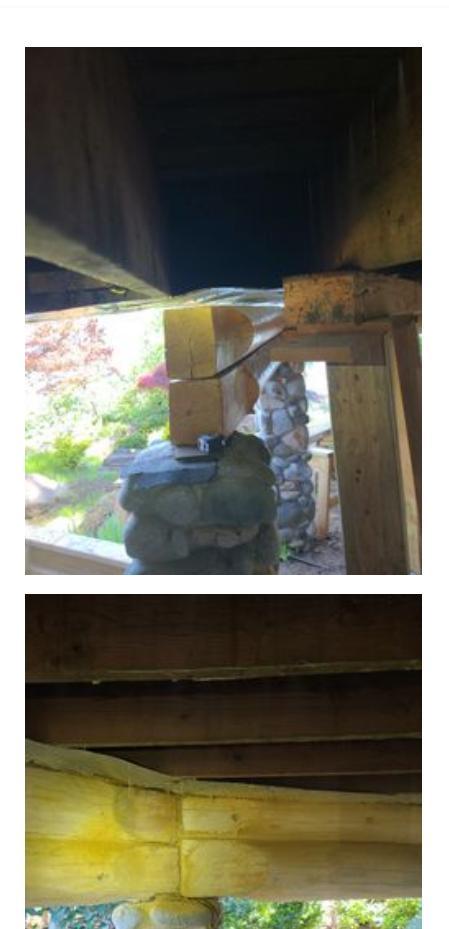
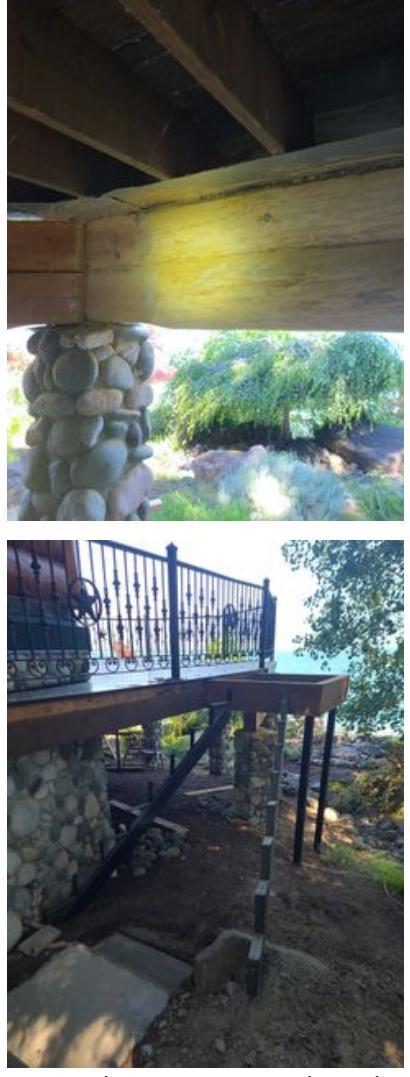
There seems to be some temporary framing still installed below the water side deck. Complete deck repairs and remove temporary framing as needed.

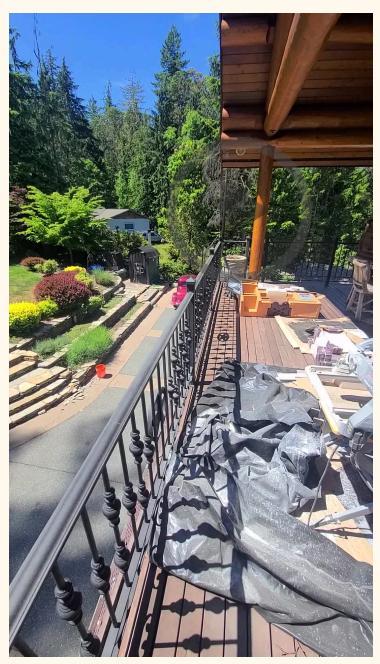
The guardrail system for the east side balcony is loose. Secure as is feasible.

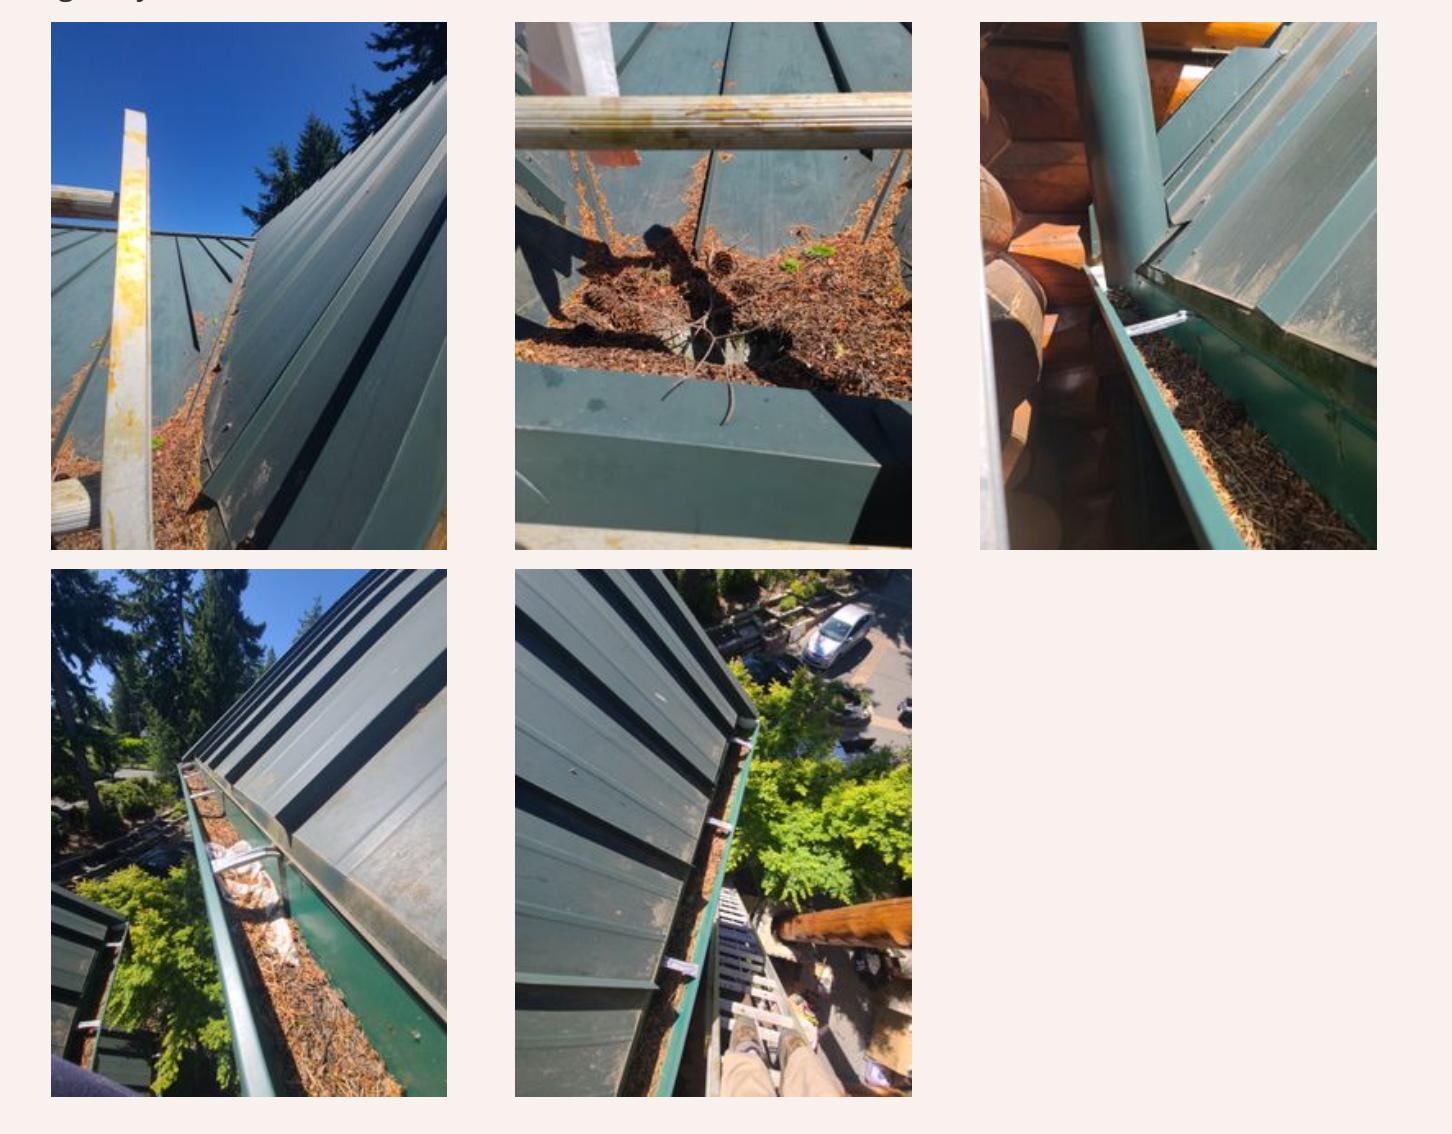
The gutters are clogged with organic debris and require cleaning to ensure proper control of roof runoff. Clean the gutters and ensure they are unobstructed, leak-free and properly sloped to drain. This is routine house maintenance; I would expect the need to clean gutters and downspouts regularly.

This is routine house maintenance; I would expect the need to clean gutters and downspouts regularly.

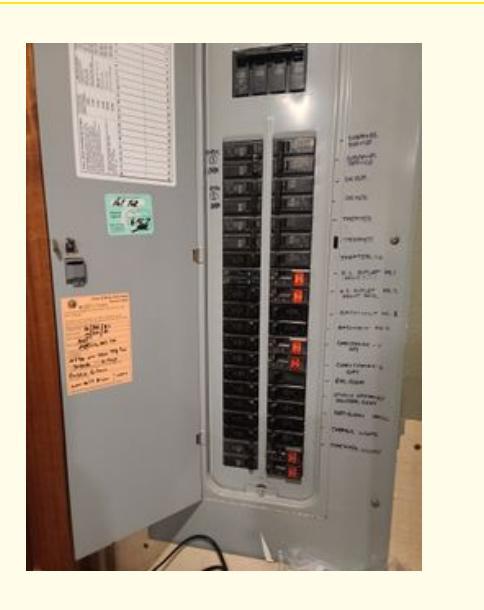
No surge protection was noted at the electrical equipment today. The 2020 edition of the National Electric Code requires type I or type 2 surge protection on new or renovated homes. Though not adopted yet this code change reflects the growing complexity of electric appliances in our houses and the growing risk of damage to electrical equipment due to internal or external electrical surges. This short video explains more about electrical surges and surge protection. I recommend upgrading and adding surge protection for improved protection of the electrical appliances in this building. I would do this in the context of other electrical repairs or upgrades.

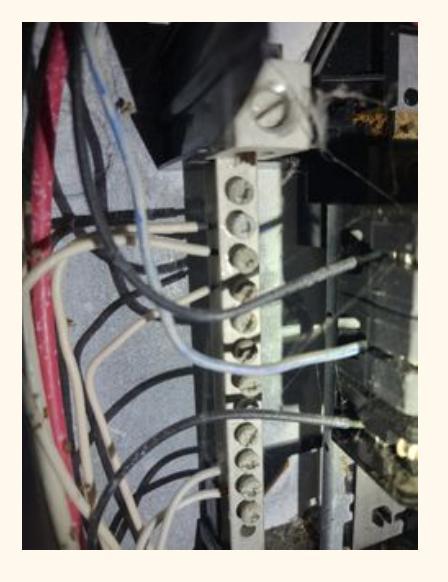
Mild corrosion was noted to several of the circuits inside the sub panel for the wellhouse. This is often caused when chlorine is stored near by an electric panel. I also noted several open cover plates in the wellhouse as well as a dead rodent in the light switch. Implement rodent control work and wiring cleanup work for the well house. I would have the panel further investigated by the license electrical contractor and terminations repaired as deemed necessary.

Mild corrosion noted on some of the conductors at the well house

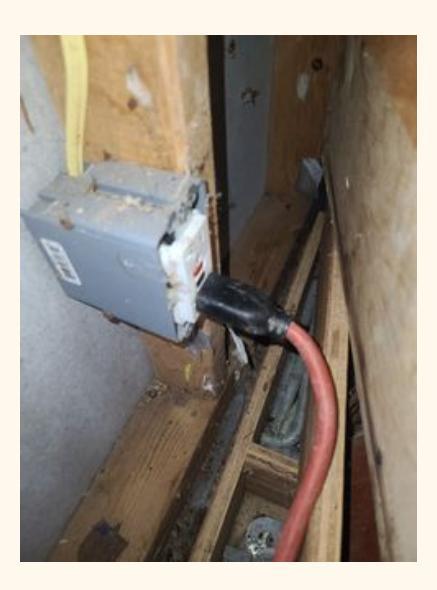
Missing cover plates in the well house - also note the dead rodent

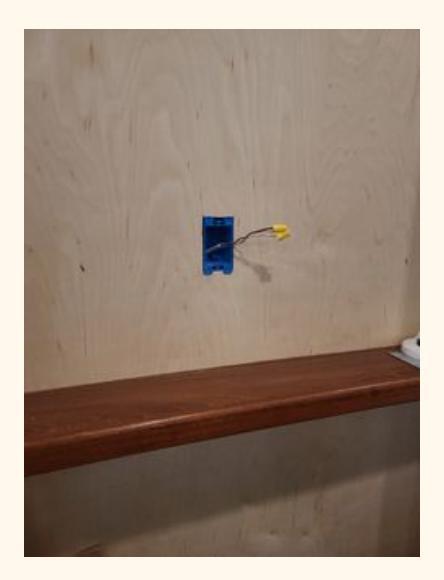
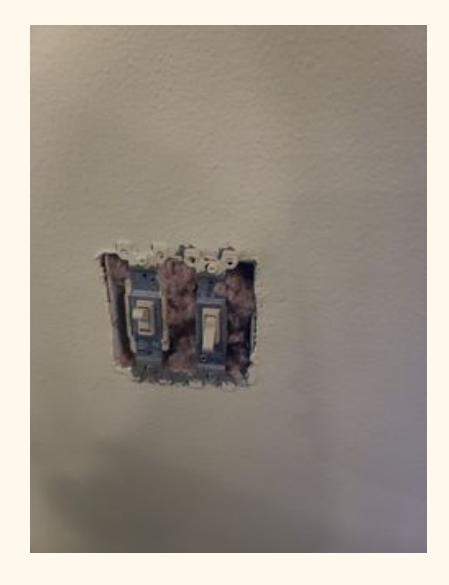
Open wiring was noted in the basement and several locations

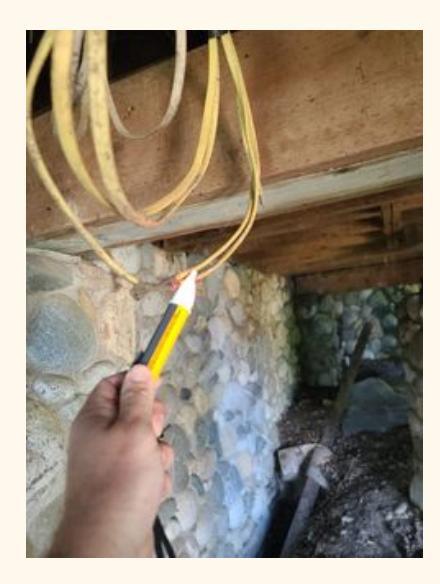
Abandoned and energized wiring was noted below the deck on the south side of the building

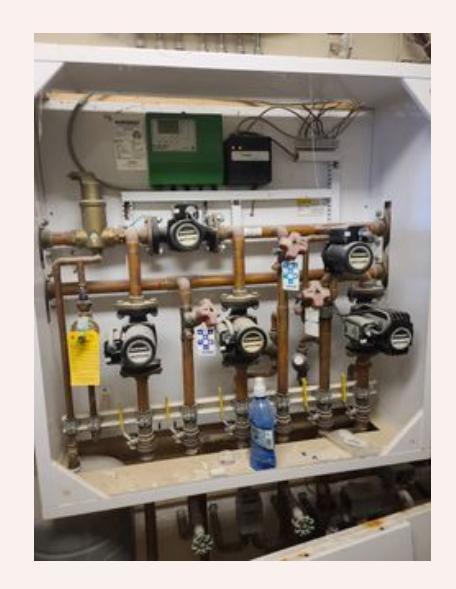
Corrosion noted on a few sections of copper manifold in the boiler room - this is typical.

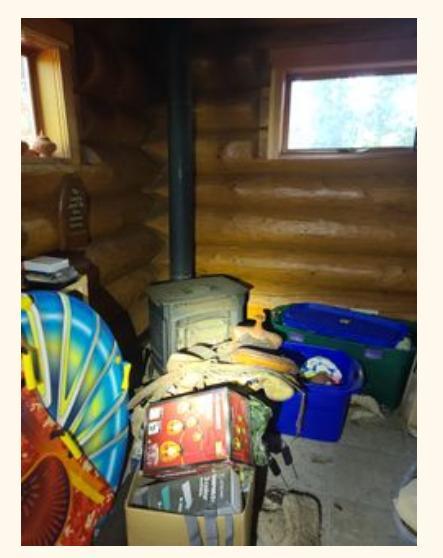
HCFV-9 Heating, Cooling, Fireplaces and Ventilation: GAS LOG FIREPLACE SHUT DOWN The gas log fireplace has been shut down and was not responding to normal operating controls. I recommend making this unit operational prior to listing the house.

The gas log fireplace has been shut down and was not responding to normal operating controls. I recommend making this unit operational prior to listing the house.

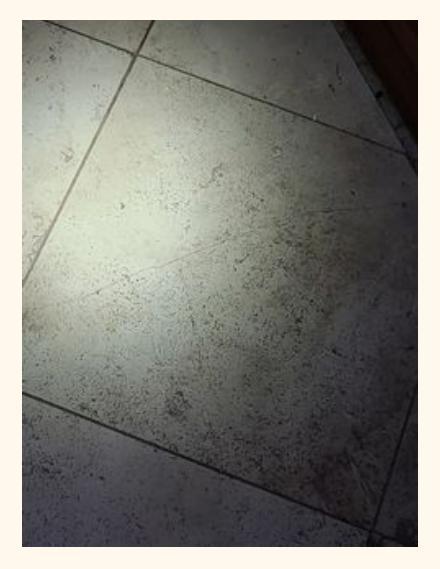
💊 - I did not find loose tile. These are likely not worth correcting at this time.

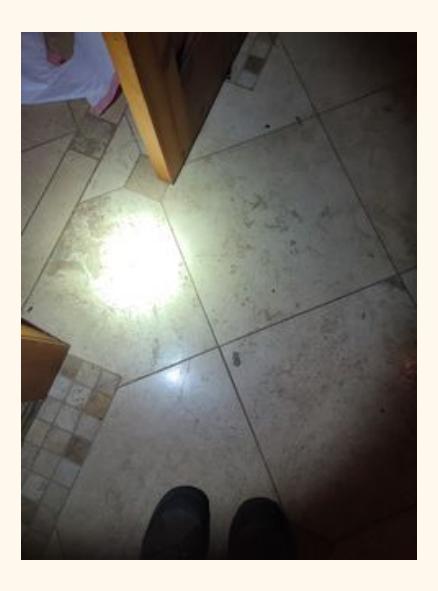
I suspect the humps in the floor are related to some of these hairline cracks

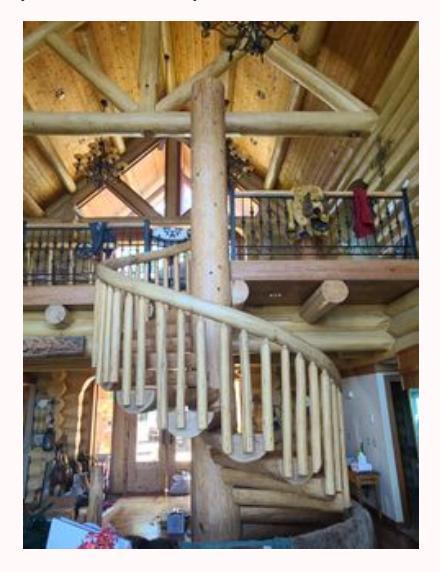
This building has a sequence of custom wood timbered stairs. These are unique spiral stairs that are beautiful but could use a round of repairs. There are a number of places where stair treads are coming loose and balusters are loose and or missing. Repair are important for safety. Examples of observations noted during inspection include:

The guardrail system is incomplete for the exterior of spiral stairs on the south side also noted treads are loose from missing balusters

Hire qualified general contractor to further evaluate and repair all of the stair systems in this building to ensure safe and reliable performance.

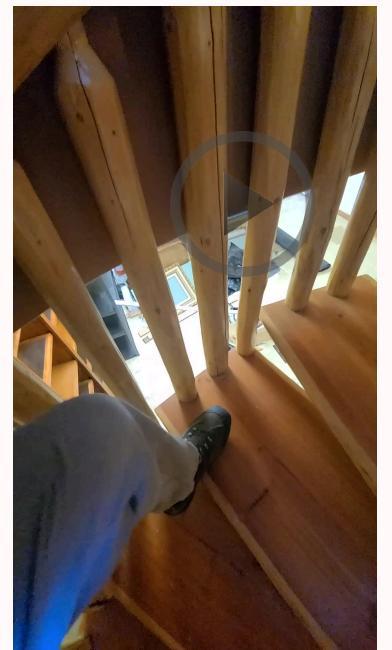
South side spiral stairs were under construction at the time of inspection

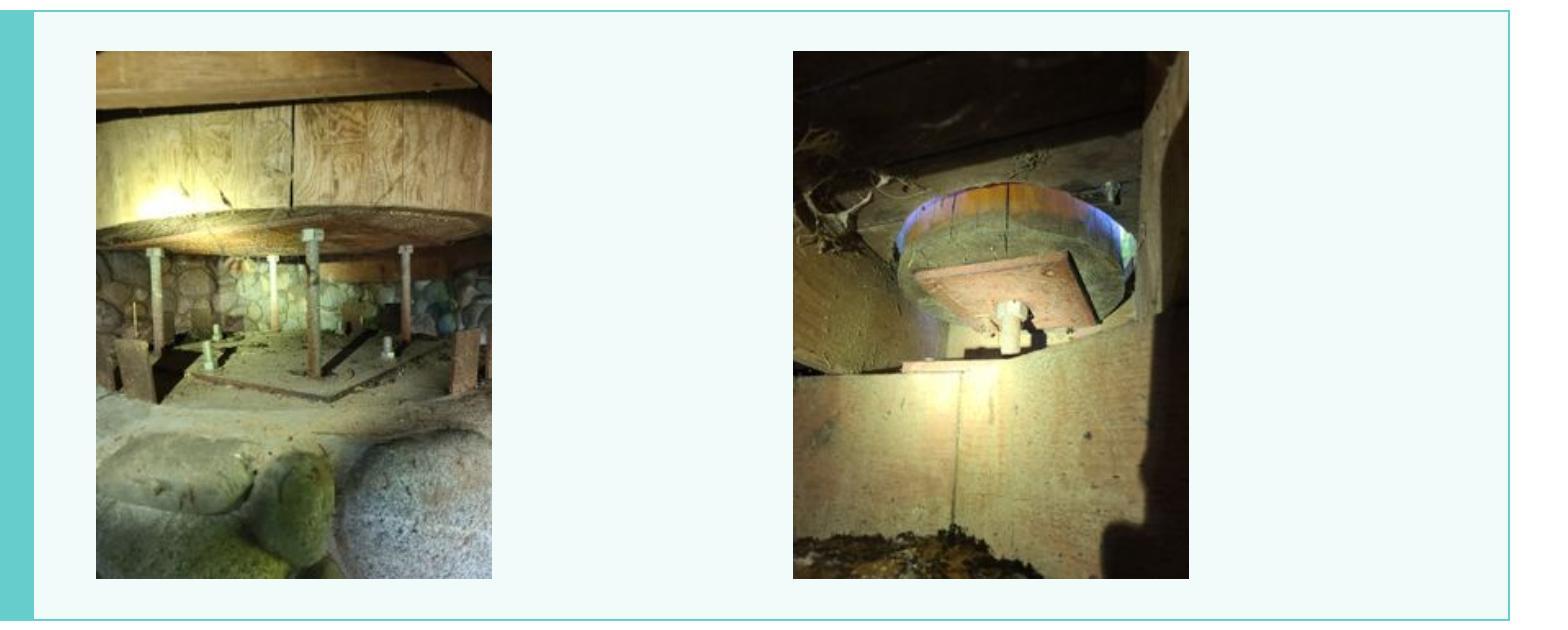
I noted a number of places where large timber posts are adjustable - see for example below the south spiral stairs.

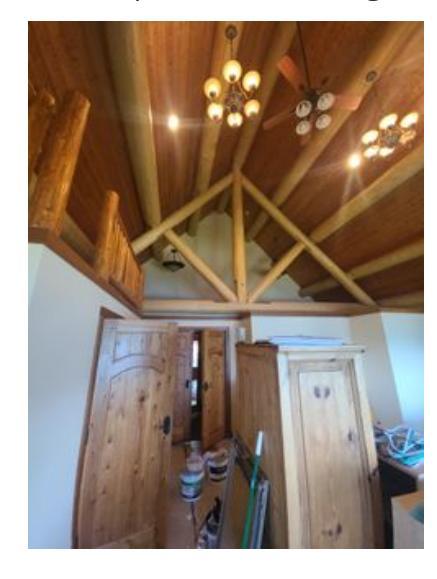
The loft spaces are missing the ladder systems. Install as needed.

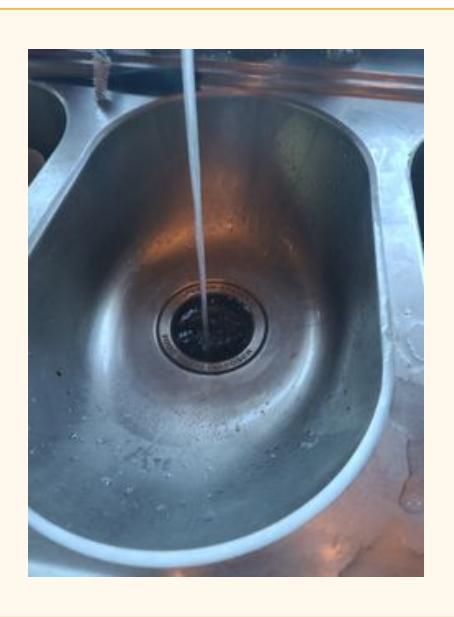
Poor functional flow was noted at the kitchen sink faucet. This could be from localized restrictions in the aerator or angle stops of faucet or could be indicative of a larger supply piping problem. Have this further investigated and repaired as needed by a licensed plumber.

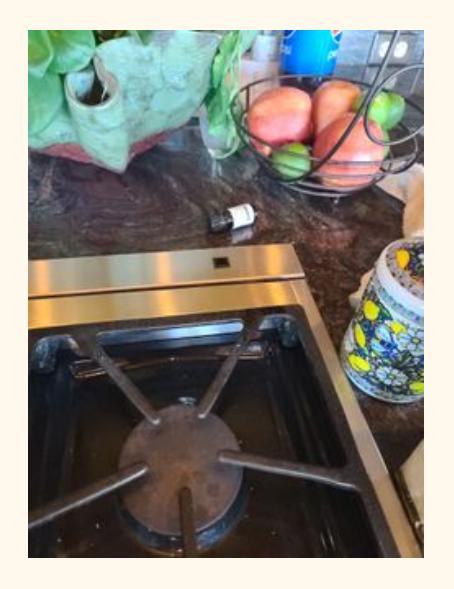
The kitchen cooktop fan is inoperative and requires repair or replacement. This is important to provide reliable ventilation for the kitchen. Have this fan repaired or replaced as needed by a qualified general contractor.

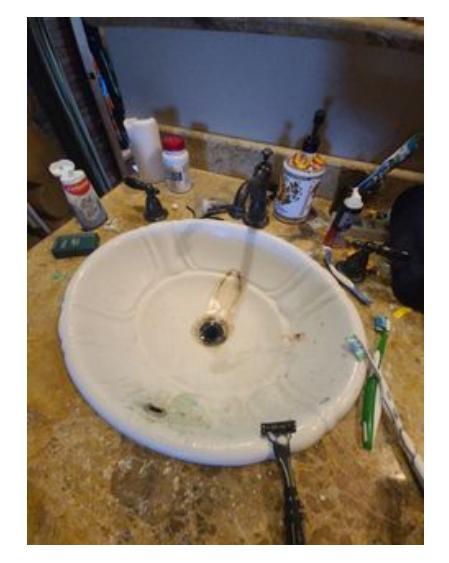
An inoperative sync stopper was noted at the right side main bath sink

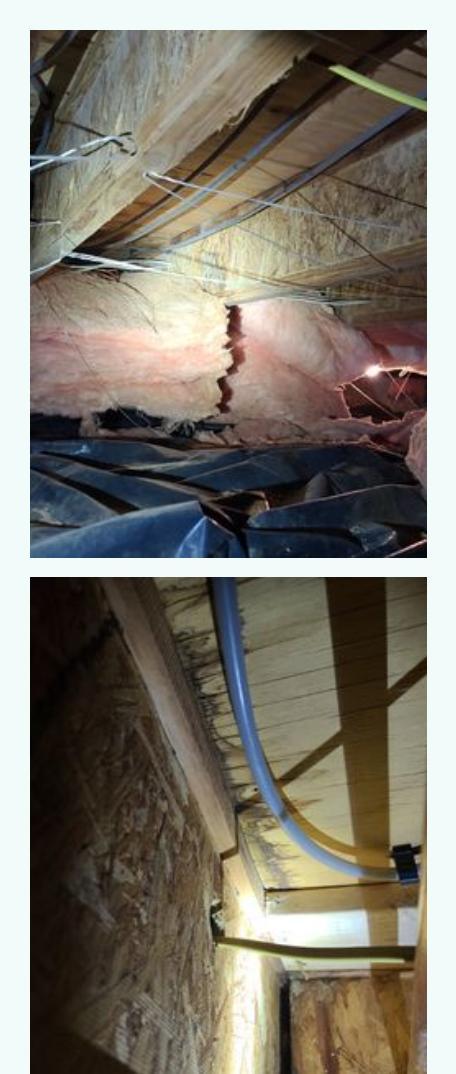
Rotten plywood was noted below the main bath shower. This was dry at the time of inspection but damaged plywood was noted.

There is some rotted plywood this is likely not worth correcting at this time.

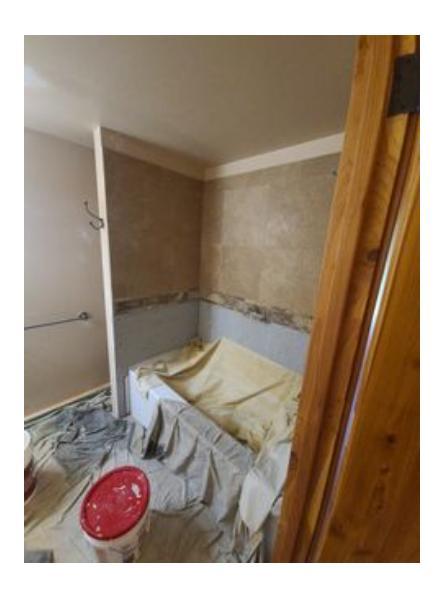
The guest bathroom is in the midst of a renovation. Complete remodel work here as needed.

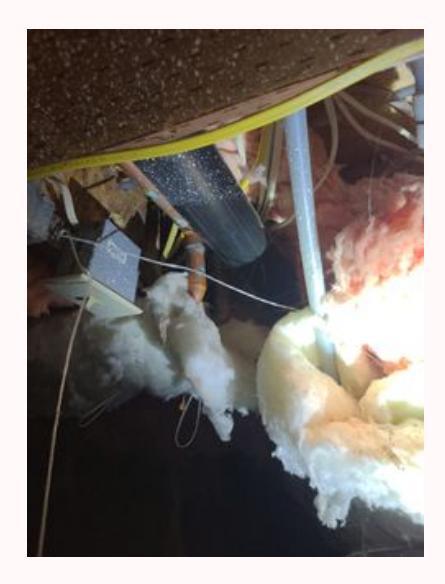
Pipe insulation is incomplete in the crawl space - be sure all pipes are insulated

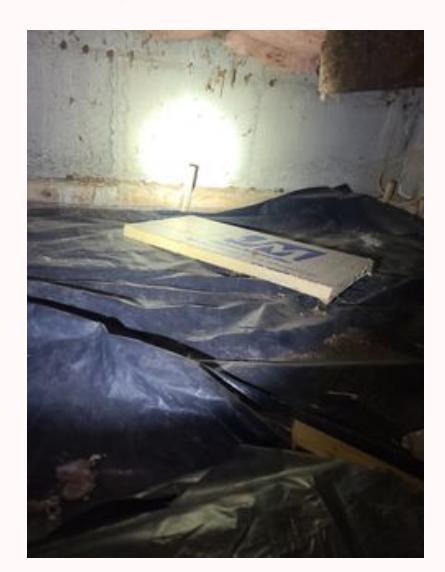
Remove all wood debris from the crawl space to eliminate conditions conducive to wood destroying organisms

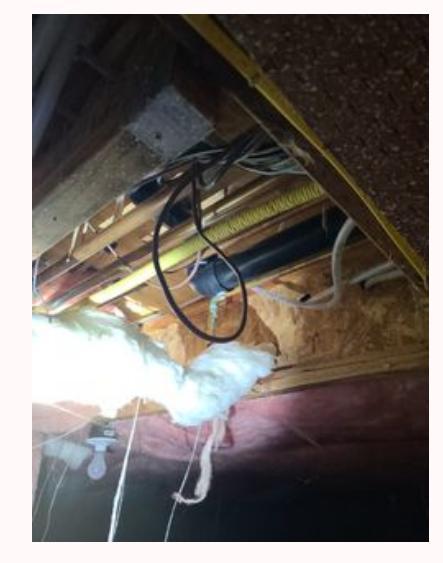
Strip off/remove all form wood in the crawl space to eliminate a condition conducive to wood destroying organisms
