Inspection report for the property at , Bremerton, WA

This report is prepared exclusively for **Joe Smith** Inspected On: **06-05-2023**

Company Information Clearview Property Inspections 678-488-9479 jeff@clearviewproperty.biz www.clearviewproperty.biz Published Report

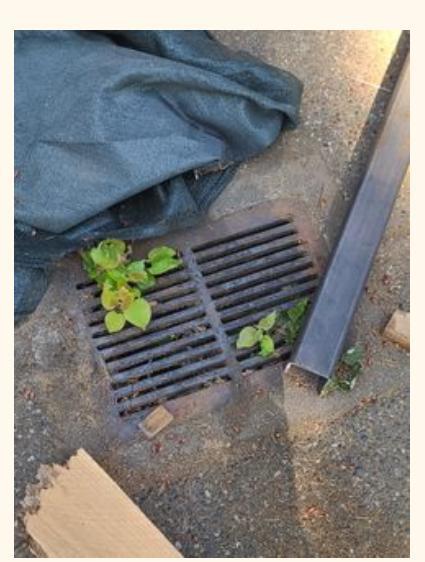
구 (G-3) Repair:

The catch basins are clogged with organic debris and require cleaning to ensure reliable performance of the drainage system.

Cleaning the catch basins around the property is recommended

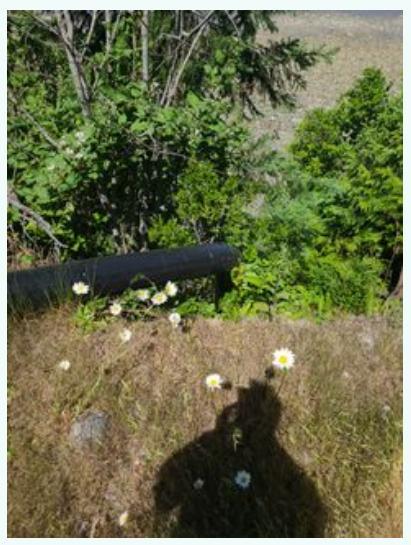
(G-4) Completed:

A large drain pipe noted going down the hillside. Disclose to a buyer any site drainage information.

A large drain pipe noted going down the hillside

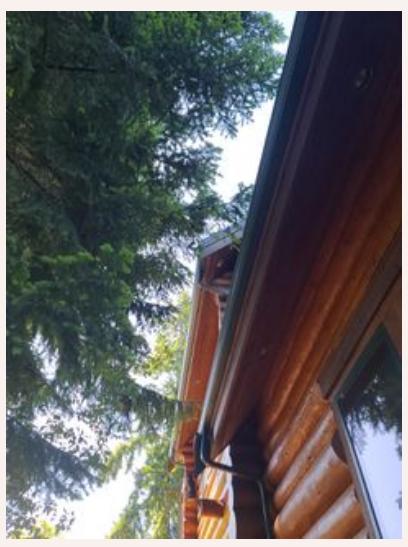
% (G-5) Recommended Maintenance: TREE AND VEGETATION PRUNING - NORTH SIDE

Pruning trees and vegetation off the building is recommended

Pruning trees, branches and vegetation away from the building is recommended. Where trees, branches and large shrubs can provide rodent access to the roof, a minimum 6-foot clearance is recommended as many rodents can jump 6-feet. All vegetation, including smaller landscaping such as grasses, flowers and shrubs should be kept 1-foot off the house to eliminate contact which could trap moisture against the building.

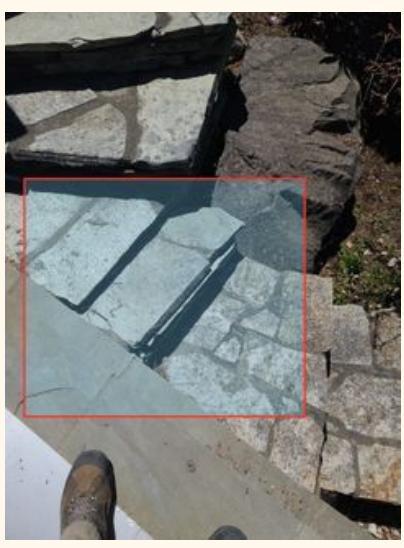
7 (G-6) Repair:

One of the stone yard stairs is out of position by the spa this could be a trip hazard. Repair as needed.

One of the stone yard stairs is out of position by the spa this could be a trip hazard.

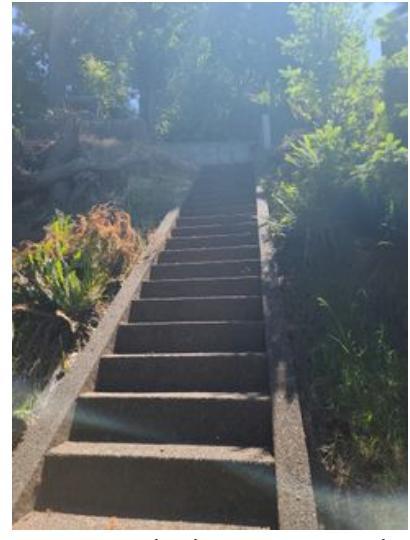
Apparently there is a metal guard system that is going to be installed for the beach stairs

Consult with a qualified genera contractor about options for improving beach stairs as desired for improved safety and reliability. I list as an incomplete item as I believe a railing system was scheduled for installation.

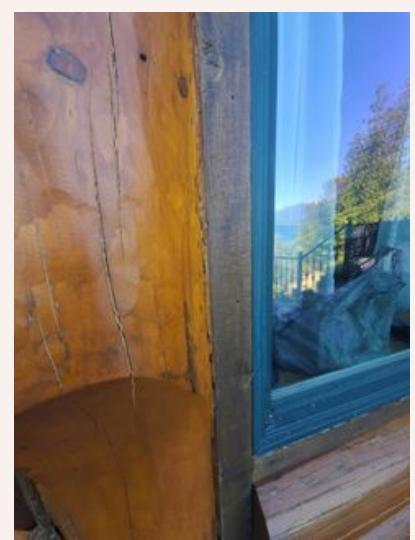
Caulking to failure noted at the water side of the building

Hire a qualified log home maintenance specialist to further evaluate and implement repairs / maintenance as recommended. Also, disclose to a new owner who has been used for maintenance and any products used for exterior maintenance.

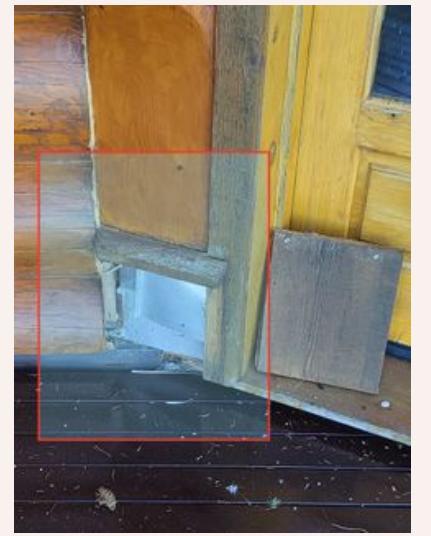
Trim wood is missing an incomplete the water side deck door

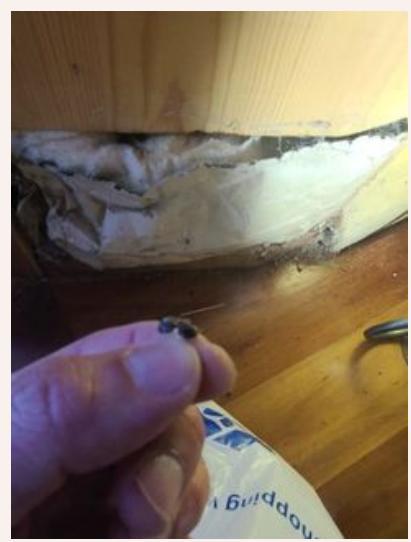
A dead carpenter ant was noted inside in this area.

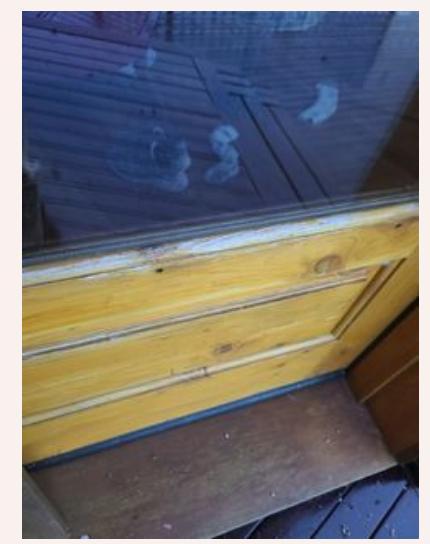
Exterior finishes are deteriorating in some exposed locations. This shows the water side deck door

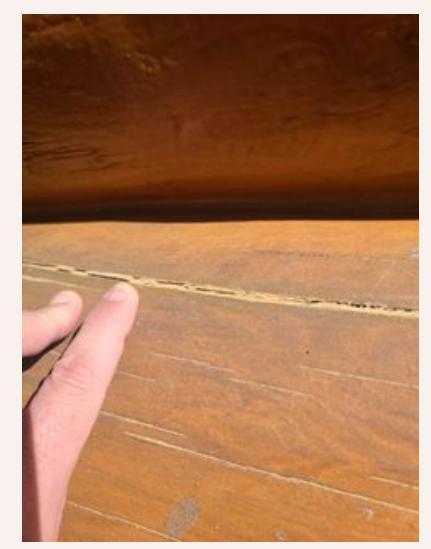
Minor cracks are developing in the sealant used to seal checks in sun-exposed logs - re-sealing will be needed soon.

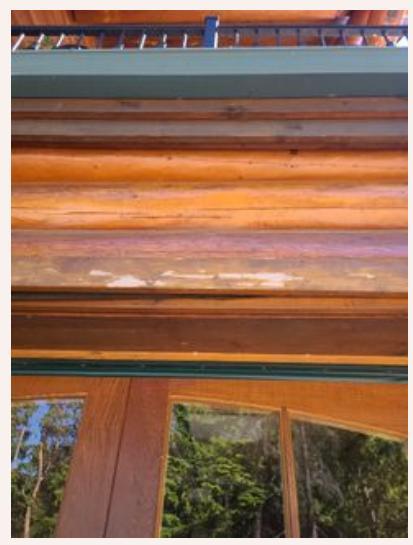
Stain failure noted in several places

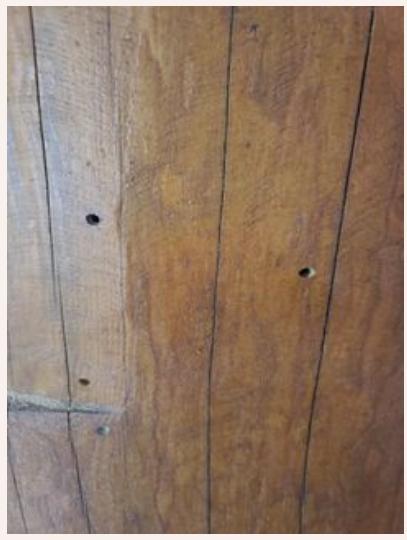
Exit holes noted in the logs on the south stairs and the entry posts. These may be old or even original.... difficult to determine

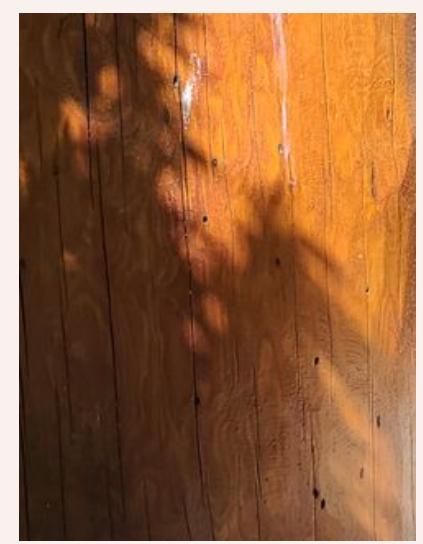
Exit holes noted in the large logs at the entry

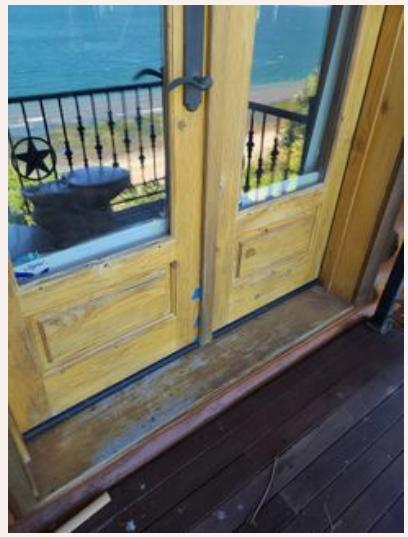
Exterior doors need refinishing at the second floor balconies

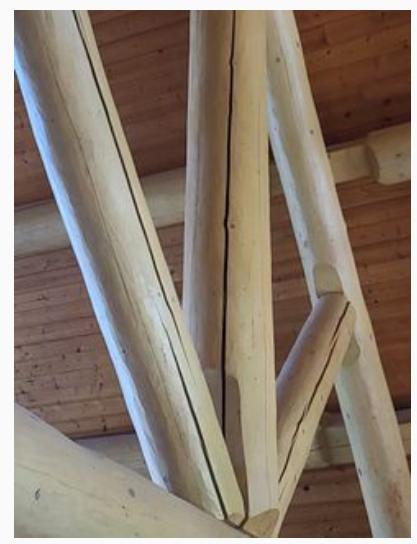
Cracks like these are known as checking - this is typical in log homes

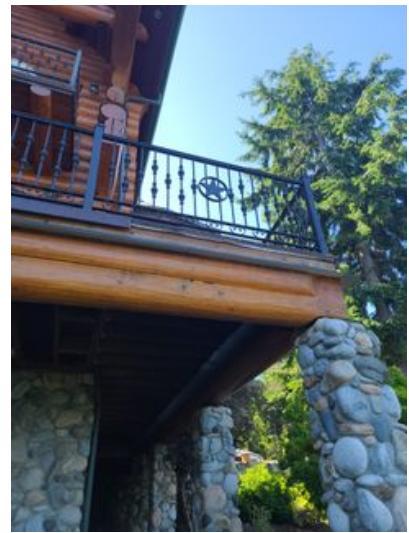
The fascia board at the Southwest corner of the water side deck is incomplete.

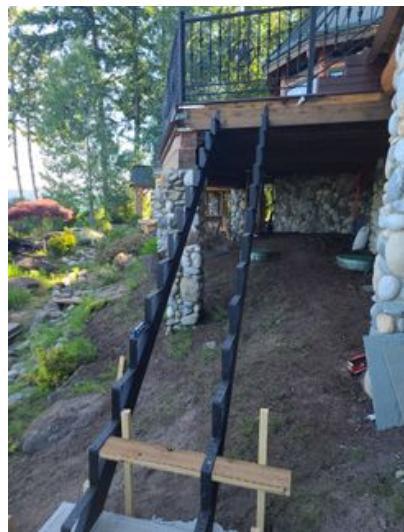
New stairs to the water side deck where under construction at the time of inspection. Complete installing stairs as needed.

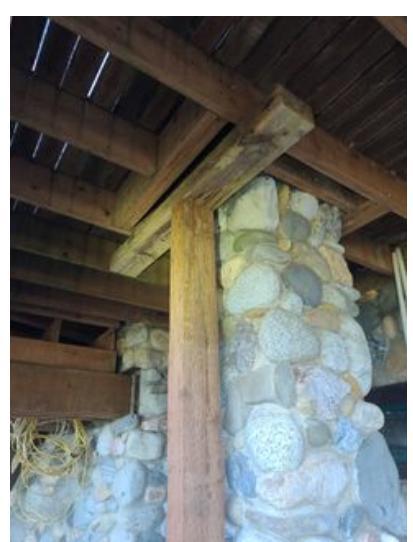
There seems to be some temporary framing still installed below the water side deck. Complete deck repairs and remove temporary framing as needed.

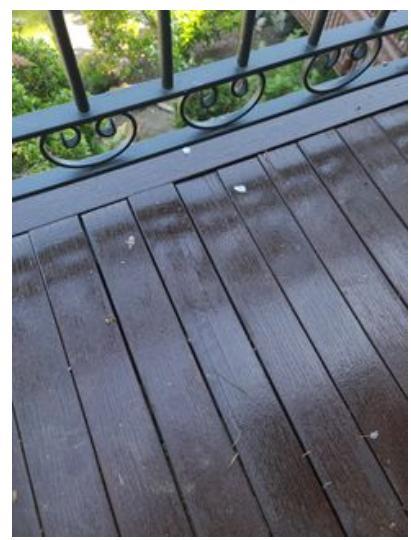
A number of loose decking boards for noted at the waterside deck. Secure as needed.

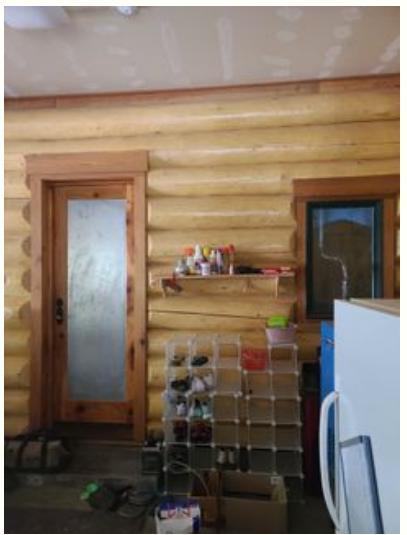
🖒 (GA-1) Note:

Typically garages require sheetrock fire separation between the garage and the living space. Presumably the solid wood walls would have been approved as they are so thick.

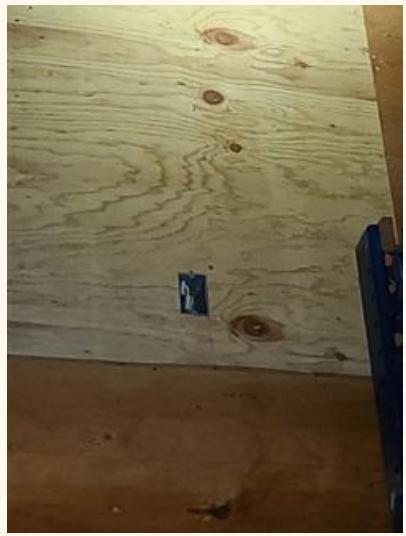
An open electrical junction box was noted in the garage storage room at the west side

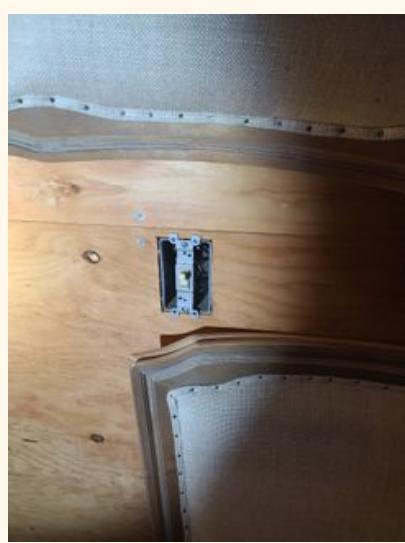
Missing cover plate for the light switch in the garage storage room

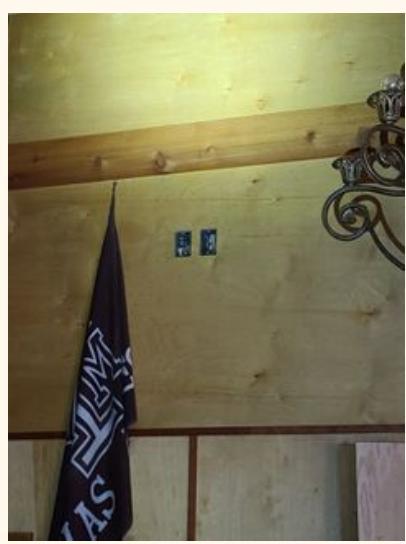
Numerous open electrical junction boxes were noted in the garage. Cover as needed.

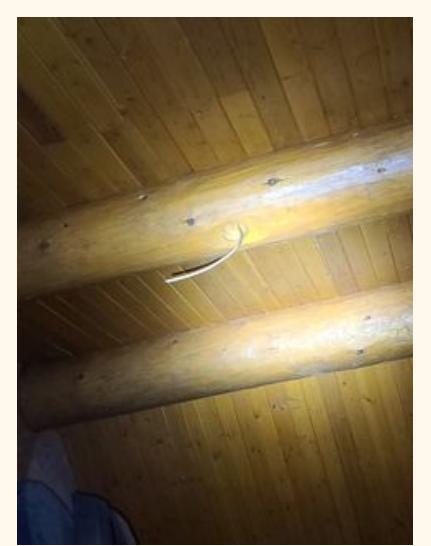
Abandoned wiring noted in the ceiling of the garage at the east side

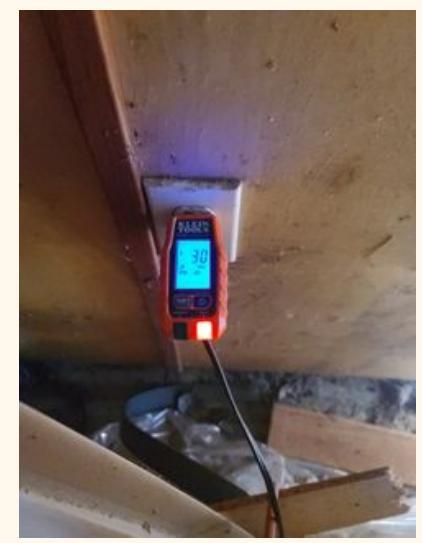
An open neutral was noted on the west wall

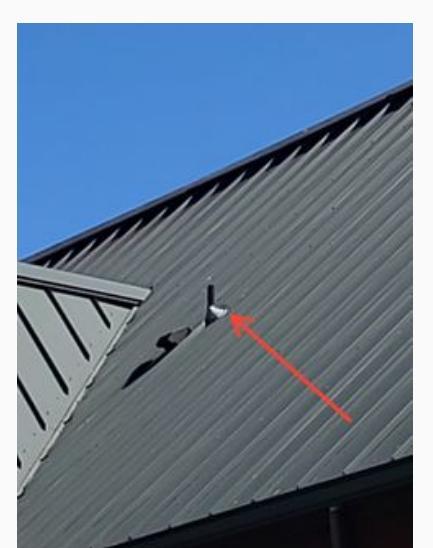
Monitor penetrations like these

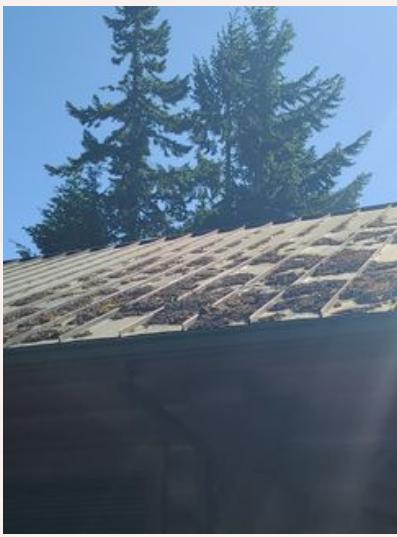
Clean organic debris off the garage roof

The roofing material on this building is a standing seem metal roof. These are often rated as 35-year roofing systems. In practice, service life depends a great deal on the quality of the roofing materiel, the quality of the installation, the steepness of the roof, roof roof design and the amount of exposure. Visual inspection today revealed the need for roof repairs to ensure reliable performance from this roof. I recommend additional inspection of this roof by a qualified roofing contractor. Repair as recommended. Examples of observations noted during inspection include:

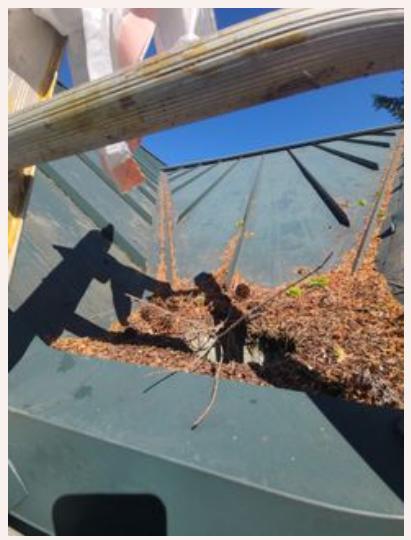
Be sure to keep this drain clear at the base of the dead valley north of the entry

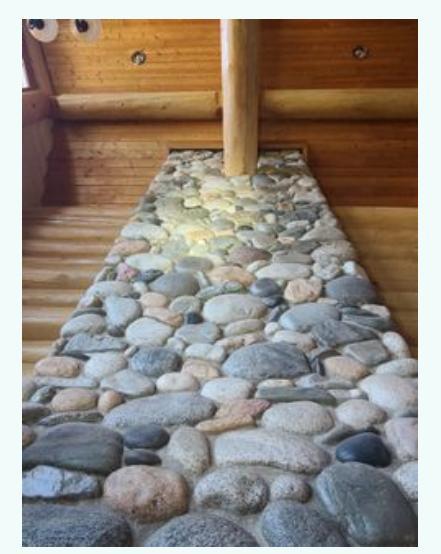
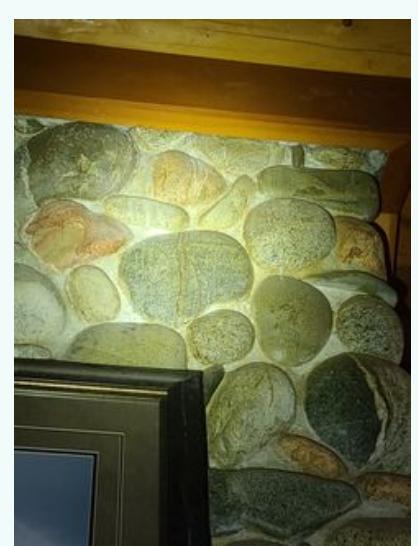
Water stains were noted on the chimney in the bedroom side of the chimney. These were dry at the time of inspection.

Water stains were noted on the chimney in the bedroom side of the chimney. These were dry at the time of inspection

Disclose any history of leakage and repair here. Chimney to roof junctures are common locations for leaks and can require ongoing maintenance.

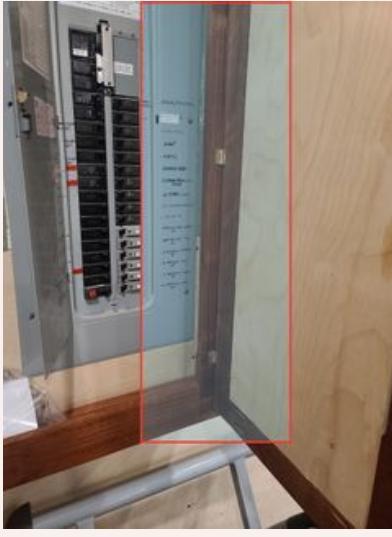
An inadequate working clearance was noted in front of the electric panel. This presents a potential safety hazard, especially for people working on or inspecting the electric panel. A 30-inch wide and 36-inch deep unobstructed working clearance is recommended for improved safety. Relocate cabinets and storage as needed to ensure safe and reliable access.

The cover for the panel obstructs access to the right side panel. This limited my inspection as I could not remove those right side screws to access the panel. Adjust / remove tis cover as needed.

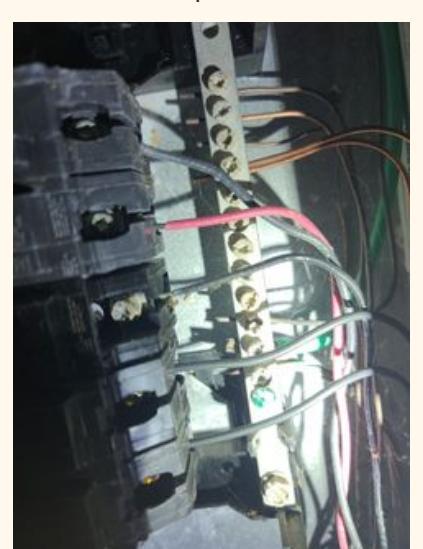
Mild corrosion was noted to several of the circuits inside the sub panel for the wellhouse. This is often caused when chlorine is stored near by an electric panel. I also noted several open cover plates in the wellhouse as well as a dead rodent in the light switch. Implement rodent control work and wiring cleanup work for the well house. I would have the panel further investigated by the license electrical contractor and terminations repaired as deemed necessary.

Mild corrosion noted on some of the conductors at the well house

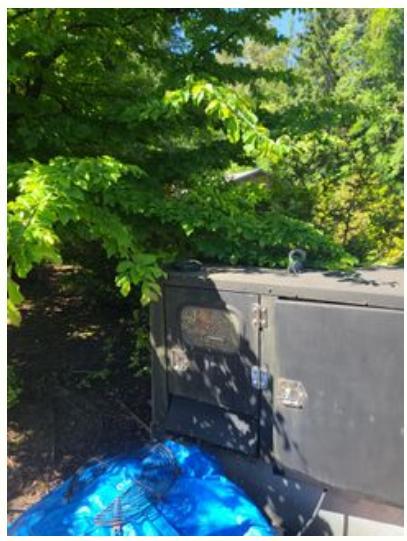
This home has a transfer switch for a generator for backup electric power supply - see the manual transfer switch on the exterior of the building to back-feed the panel. Generator systems are beyond the scope of this inspection. I recommend disclosing more information regarding the operation and maintenance of this system. Generators need to be run and serviced regularly to ensure reliable operation.

This appears to be a diesel generator. I did not see a large tank for this, just a small portable fuel tank.

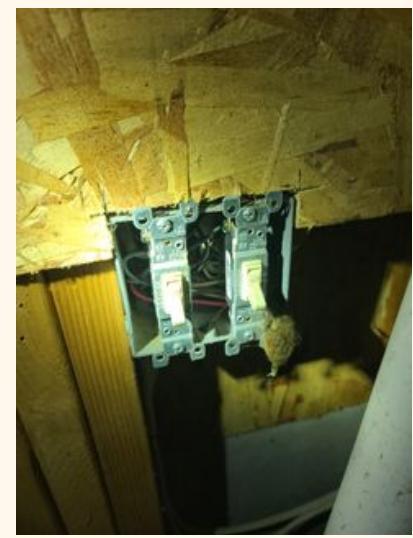
Missing cover plates in the well house - also note the dead rodent

Hire a licensed electrical contractor to further evaluate and repair these items as needed. Please also see other items in the electrical chapters of this report.

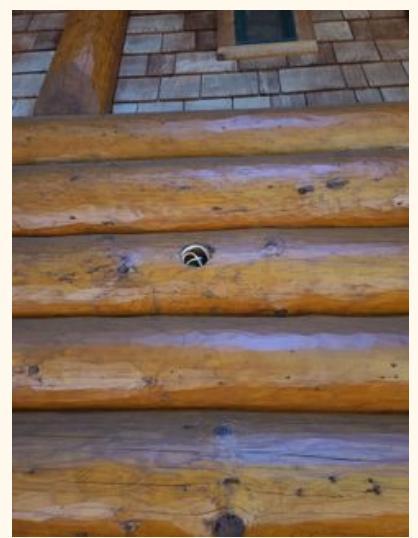
Open wiring was noted on the east side of the garage. This looks to be for a light fixture. Complete installing a light as needed.

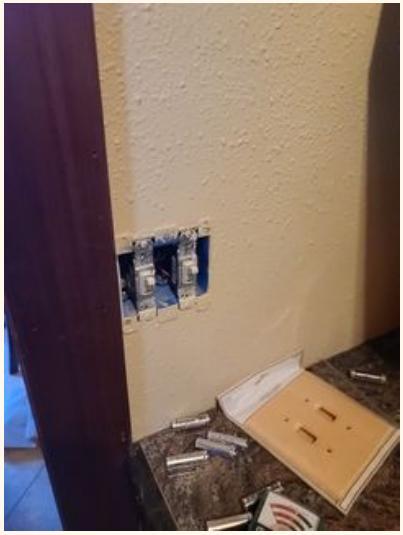
Electrical cover plates are missing in the laundry room

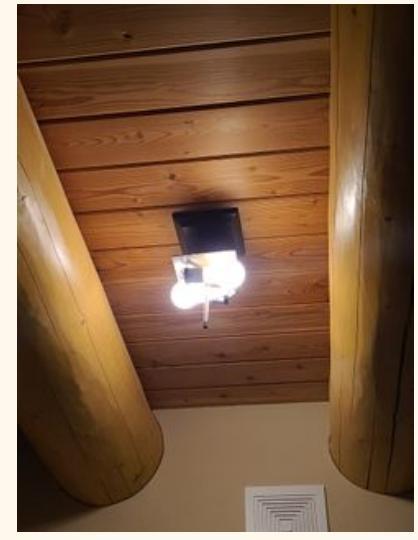
The cover for the light fixture is missing in the laundry room

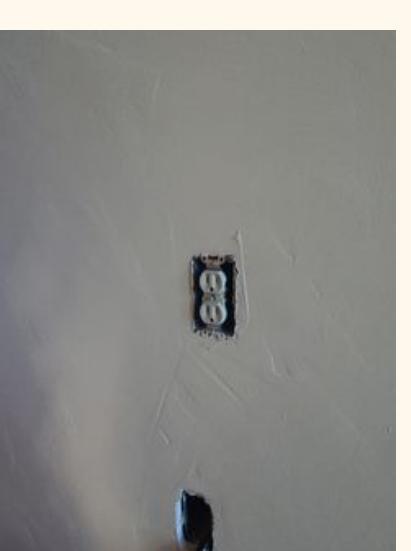
Missing electrical cover place not even in the powder bathroom

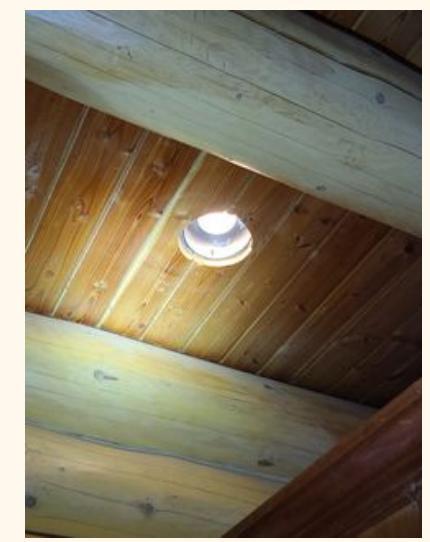
Can light trims incomplete in the kitchen ceiling.

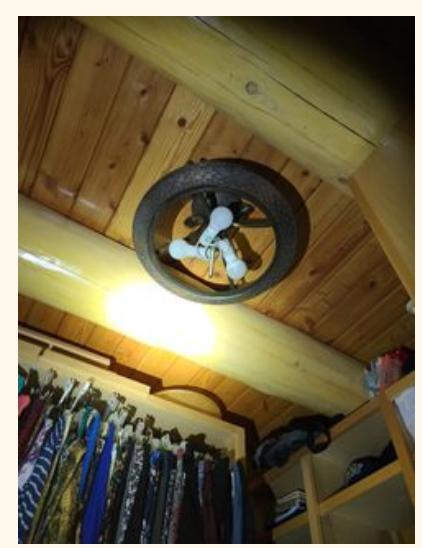
The lighting fixture in the main bedroom closet is incomplete. It seems to be missing a cover

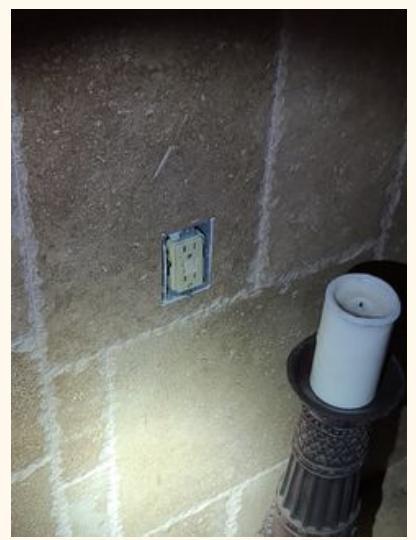
Missing GFCI cover plate - main bath

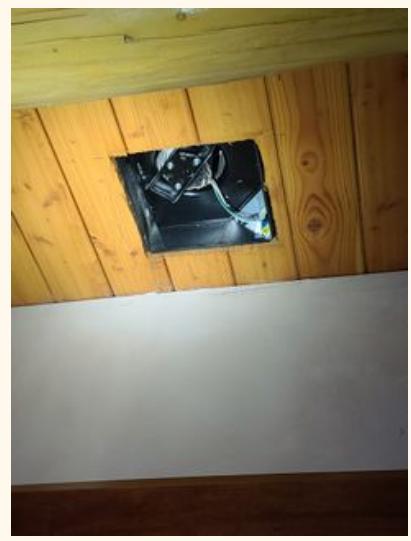
The fan in the main bath is missing its cover

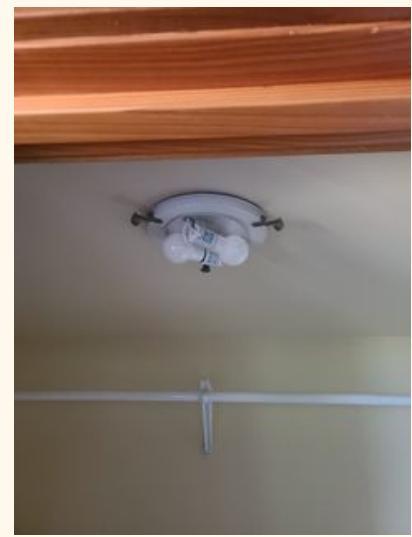
A light fixture is missing is covered in the upstairs south bedroom closet

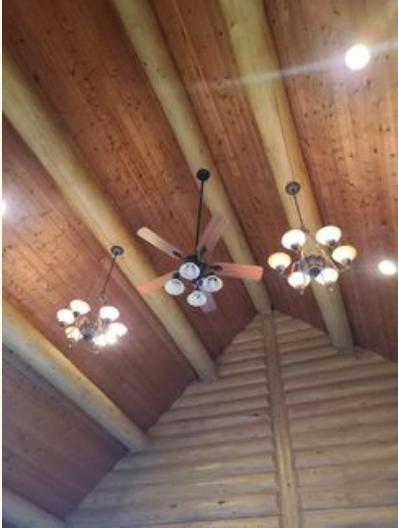
I did not find controls for these ceiling fan and light on the south side bedroom

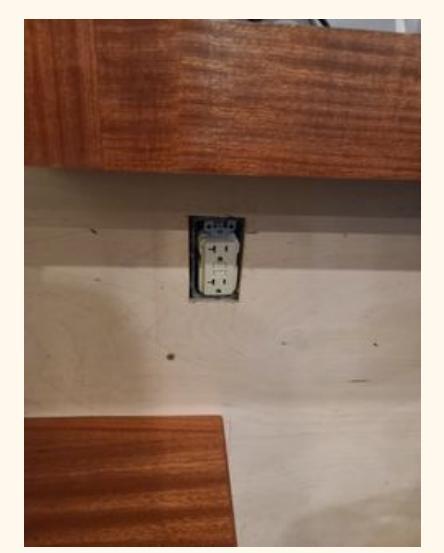
A loose receptacle was noted below the electric panels and the basement

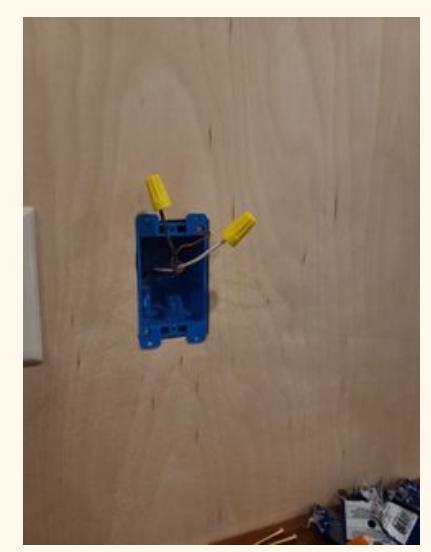
Open wiring was noted in the basement and several locations

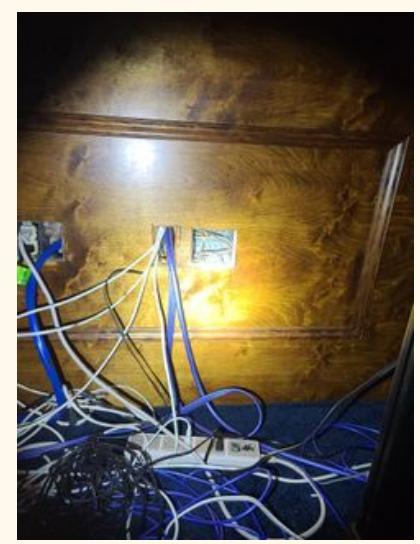
Open wiring and junction boxes loaded down in the movie theater room

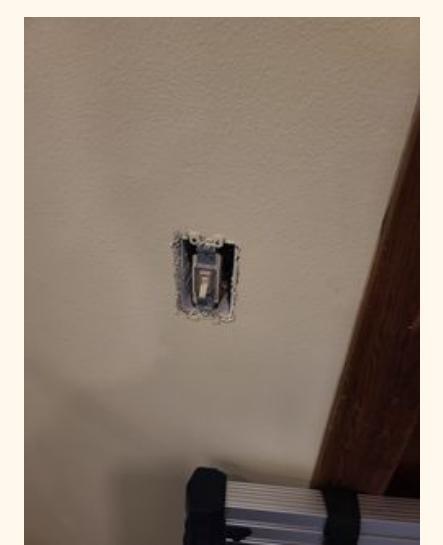
Missing electrical cover plates all over the basement

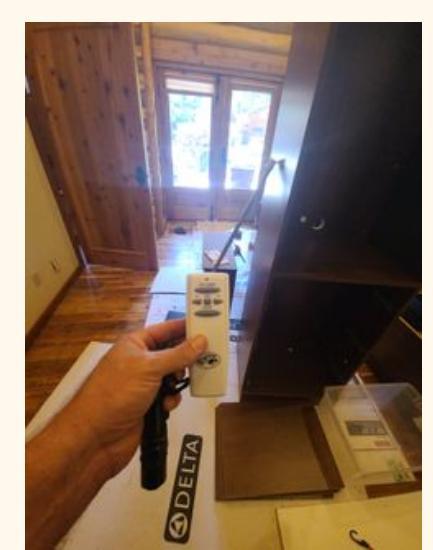
The ceiling fan in the southeast bedroom did not respond to testing.

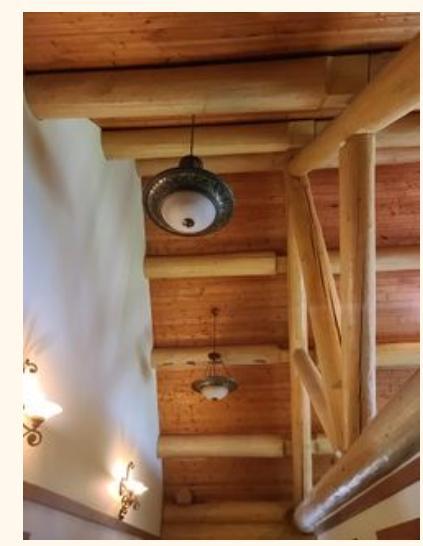
I did not find controls for the upper chandeliers in the south hallway

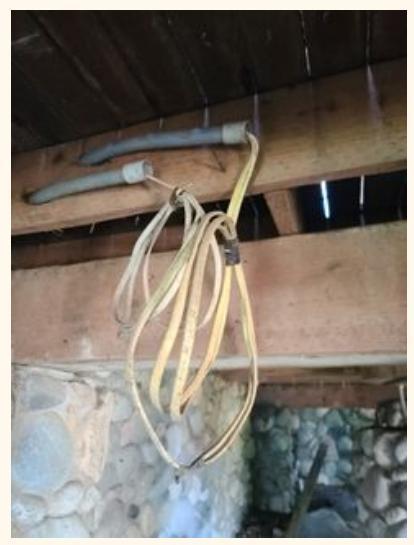
Abandoned wiring was noted on the exterior of the building - see below the back deck. This should be eliminated or properly terminated inside a listed junction box. This was tested with a noncontact voltage pen and appeared to be energized. though this method of testing is unreliable and the circuit may not be energized. For optimal safety, all abandoned wires should be eliminated or properly terminated inside a junction box. During ins[ection I noted:

Abandoned and energized wiring was noted below the deck on the south side of the building

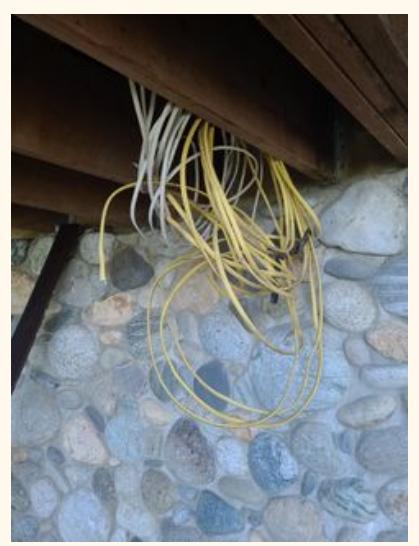
Multiple areas of abandoned wiring renoded below the water side deck

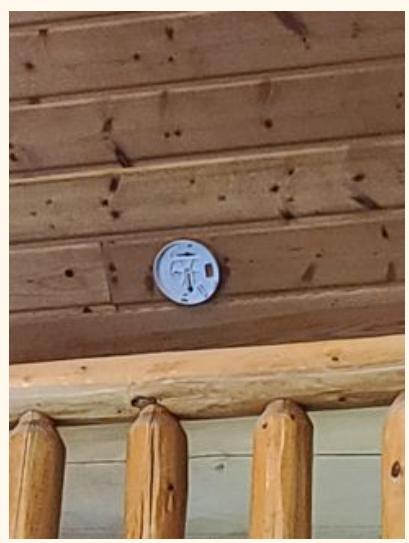
I do not see hardwiring for any of the smoke alarm holders.

(EDF-8) Repair: A number of smoke alarms are missing. Repair / replace the missing smoke alarms in the house so that there is an operating smoke alarm in every bedroom and on every floor and one outside of all sleeping areas.

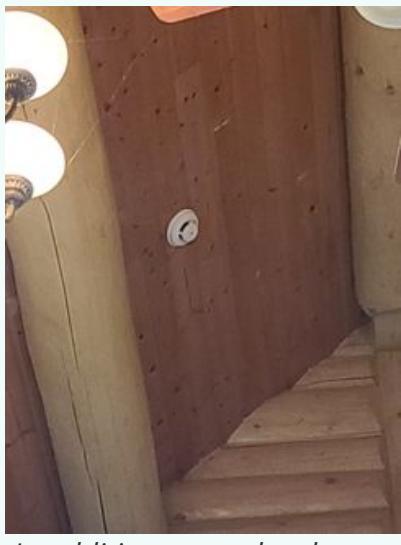
In addition to smoke alarms there seems to be a hardwired detector system.

This building has a smoke/heat detector system. Some of these can even be tied into a house security system. I do not test these systems. A critical part of the electric system tutorial is understanding this smoke detector system. Also, determine if these detectors also do carbon monoxide.

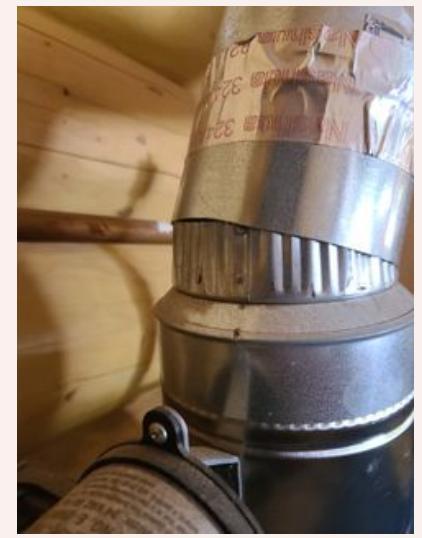
The exhaust vent for the boiler and the garage is partly disconnected and requires repair.

Hire a licensed heating contractor to service and further evaluate the boiler. I would disclose to a buyer any additional information about the installer and maintenance information. Examples of observations noted during the inspection include:

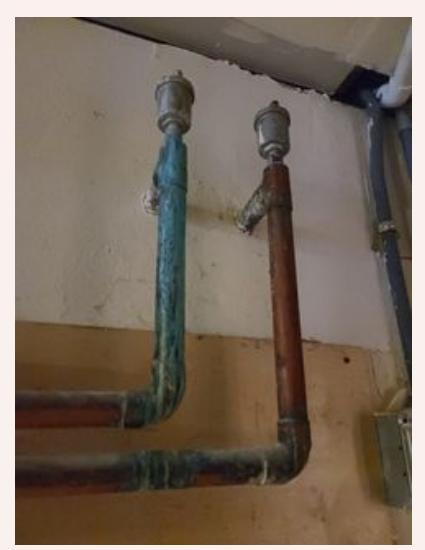
Corrosion noted on a few sections of copper manifold in the boiler room - this is typical.

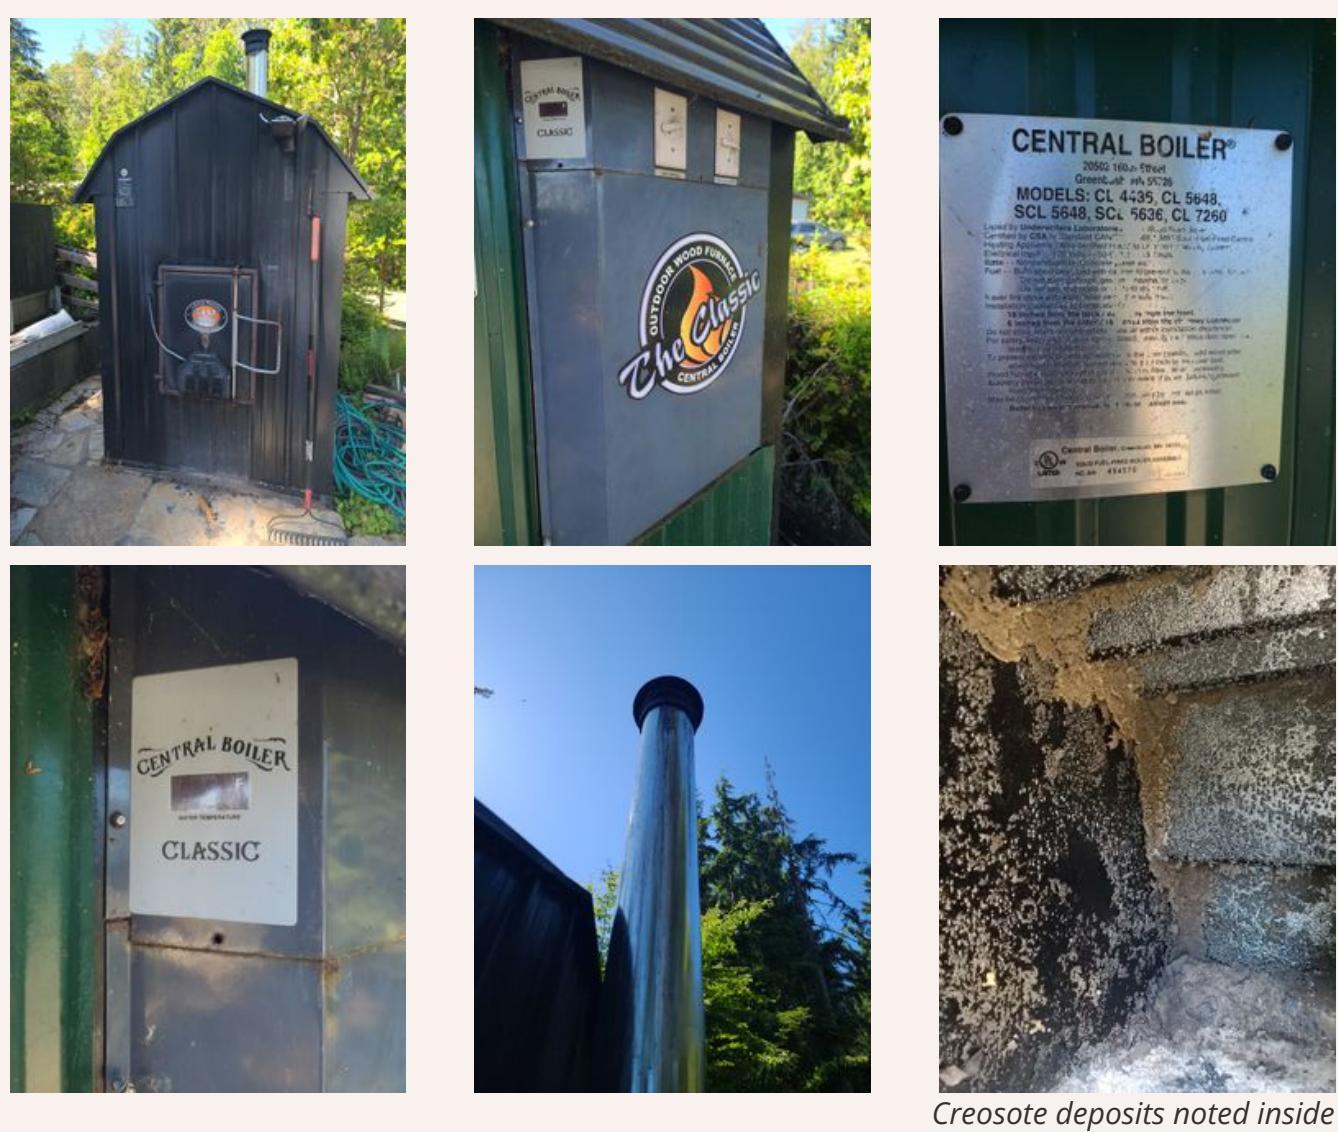
the wood fired boiler

This building appears to have a second boiler system located at the South end of the property. This is a wood fired boiler. This looks like a neat system. I have never seen one. I did not light a fire to

test the system. Visual inspection indicated fairly extensive creosote buildup inside. **Recommendation**

I recommend having this wood fired boiler service as recommended by the manufacturer. Disclose to a new owner any information about how to operate and maintain this unique system.

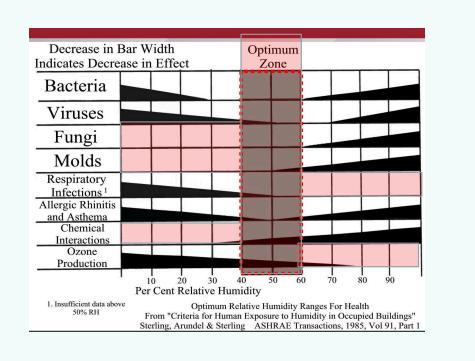
I did not find any provisions for automatic mechanical ventilation typical for a building of this age. Disclose any information about ventilation systems here. There may be a system that I overlooked. Interior ventilation systems are often not that critical on larger houses such as these.

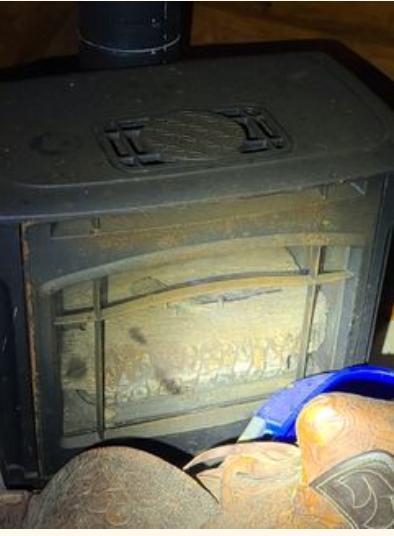
The propane wood stove in the shop was off at the time of inspection. Miled corrosion was noted on the unit and the flu termination above the roof looks to be bent. I recommend having this appliance service to and made operable as needed.

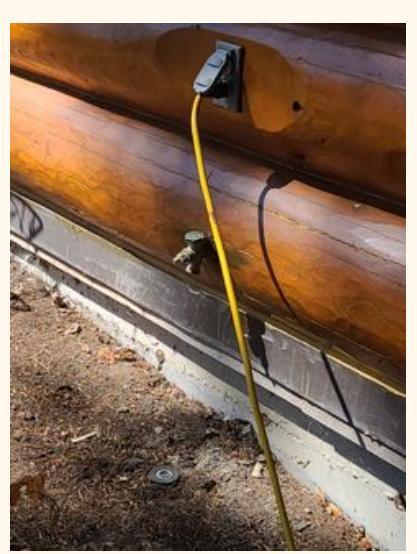
Replace the missing handle to the hose bib on the north side of the building.

Replace the missing handle to the hose bib on the north side of the building

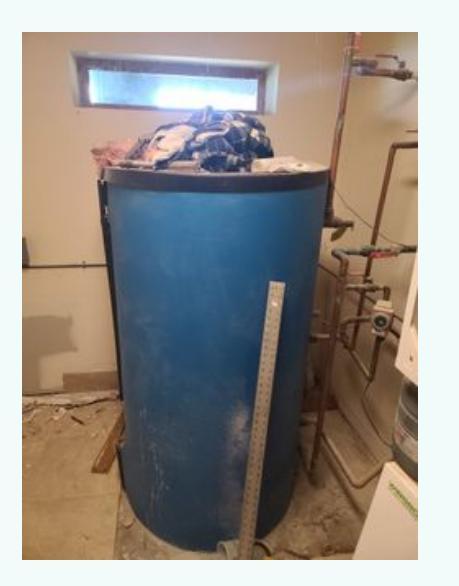
This water heater is likely close to the end of its useful service life. The average life of a water heater is statistically 8-12 years though in practice, they can vary widely between 8-20 years depending on water quality and maintenance schedule such as frequency of flushing the tank and replacing sacrificial anodes. Budget to replace this water heater at any time. Water was hot at the time of inspection.

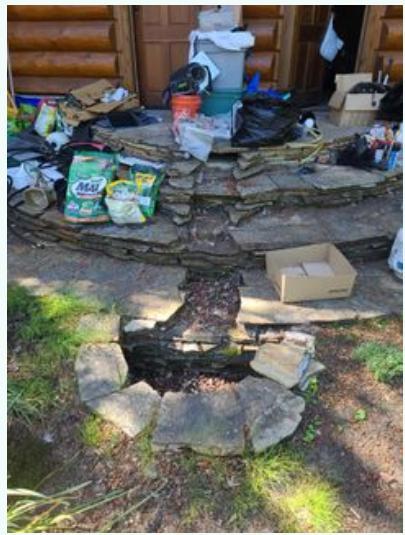
A water feature was noted on the west side of the garage. This was off at the time of inspection. Make operable as desired.

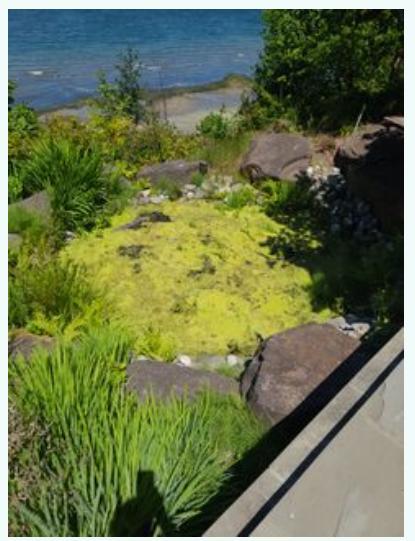
A water feature was noted below the spa

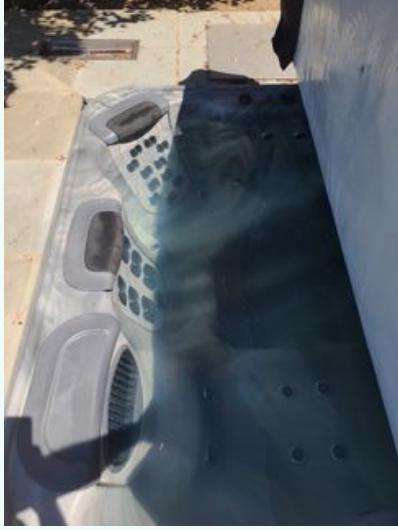
• I do not see an electrical disconnect for the spa - be sure there is a disconnect within sight of this spa

I do not see an electrical disconnect for the spa

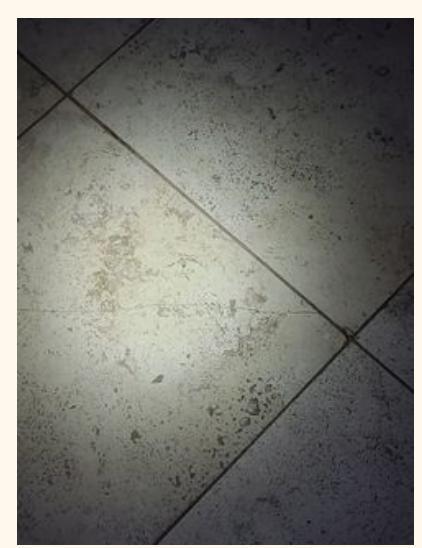
Several cracked tiles were noted in the floor during inspection - see the kitchen. Have these cracked tiles replaced by a tile specialist. Please note that cracked tile can be an indication of poor tile preparation and additional cracking could continue. In this case I suspect it is from the log framing / construction of the building. As logs shrink it is common for some sections to go out of level.

Several cracked tile were noted in the kitchen area

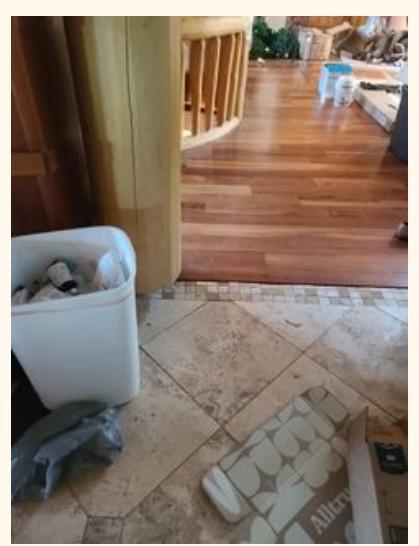
I suspect the humps in the floor are related to some of these hairline cracks

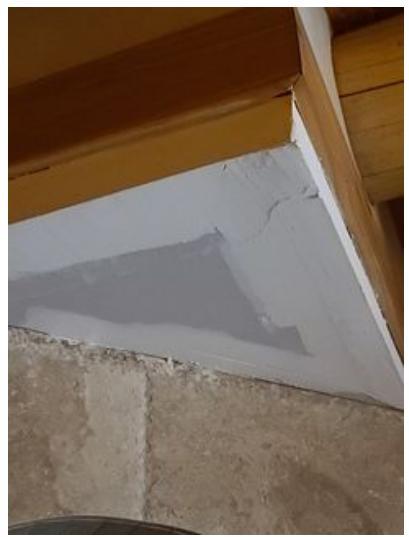
A small area of drywall finishing is incomplete above the main bath shower

Complete cosmetic sheetrock and finish repairs prior to listing as needed.

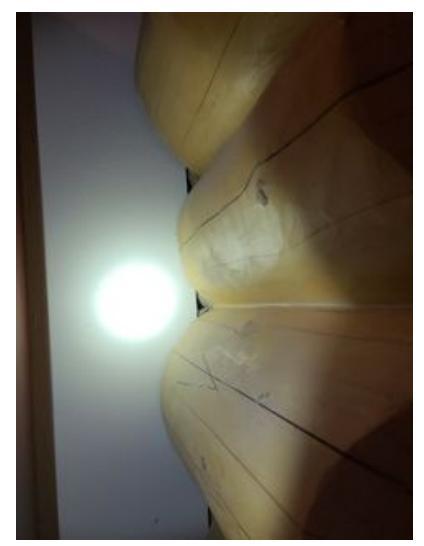
The wall to log finishes leave exposed openings in he laundry

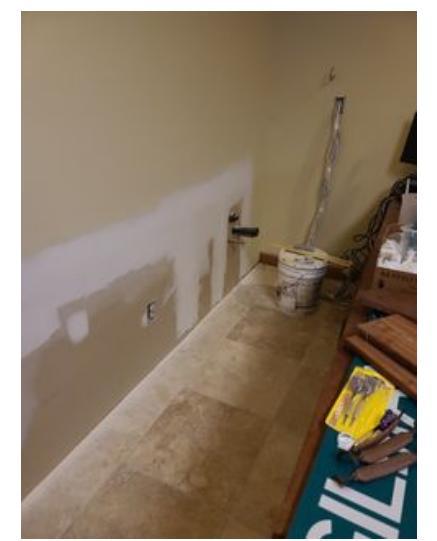
Basement finishes are incomplete behind the bar

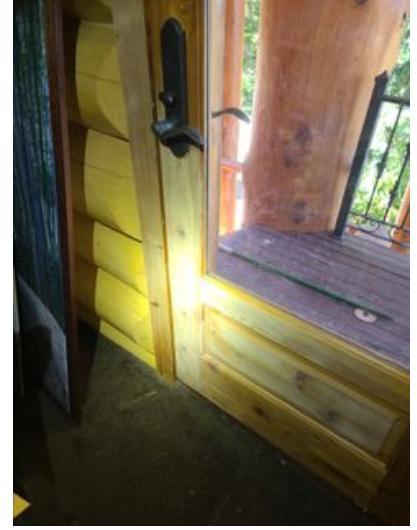
Incomplete finishes noted on the south door to the upper balcony

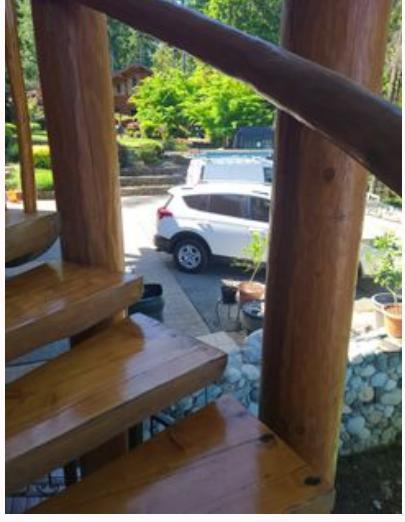
The guardrail system is incomplete for the exterior of spiral stairs on the south side also noted treads are loose from missing balusters

Hire qualified general contractor to further evaluate and repair all of the stair systems in this building to ensure safe and reliable performance.

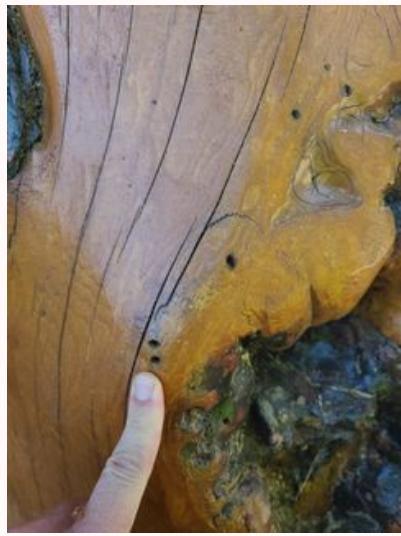
Exit holes in some of the exposed wood on the south side may be original, but treatment could be needed.

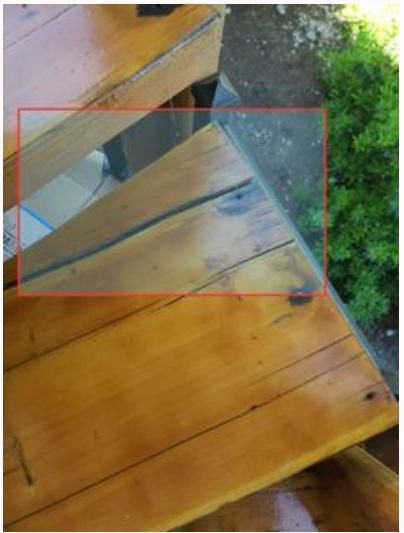
One of the stair trades is cracked to the spiral stairs at the south side exterior

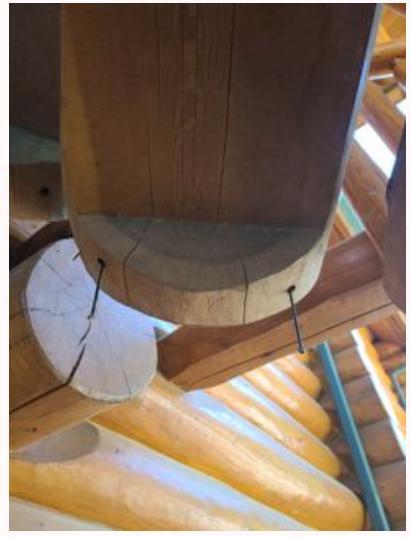
Stair treads under repair - south side

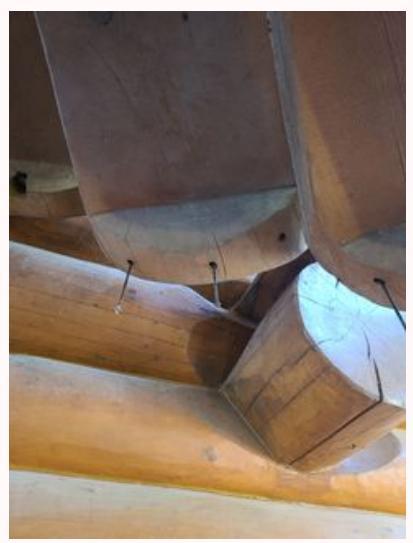
South side spiral stairs were under construction at the time of inspection

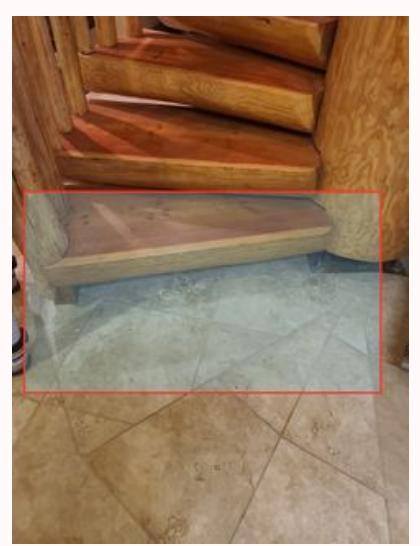
S - Please note there are a few installation issues with these stairs that may be difficult to correct to comply with modern safety standards. For example the stairs are lacking a proper graspable handrail that meets modern handrail profile requirements. There are also a number of treads with uneven riser heights. Future owners should use caution or consult with a qualified builder about options for repair as desired.

Riser heights are not all within 3/ 8th of an inch - this is a modern safety standard that could be difficult to achieve with these stairs.

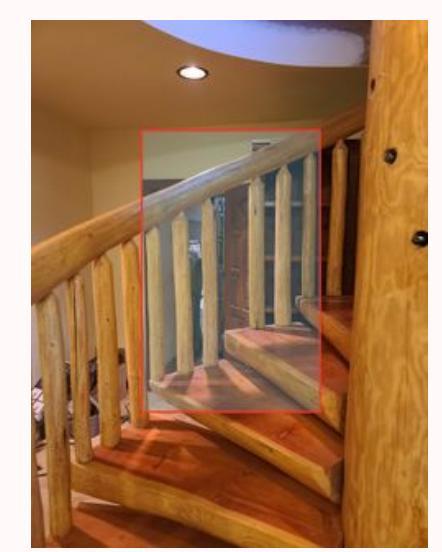
Baluster missing on lower stairs

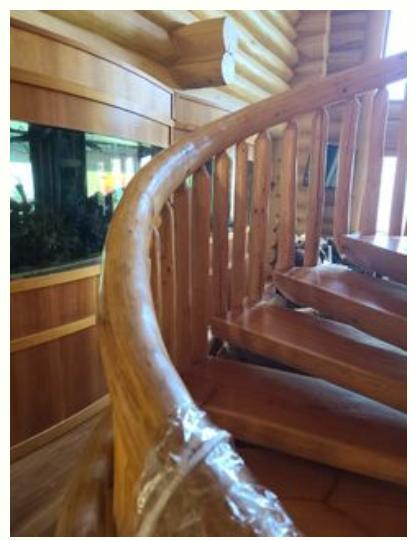
These handrails are too thick

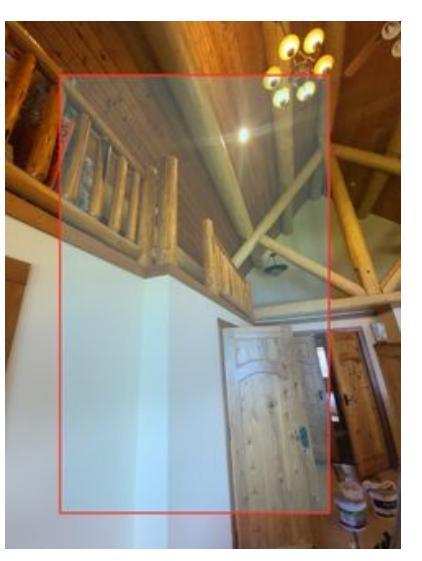
The loft spaces are missing the ladder systems. Install as needed.
