Inspection report for the property at , Bremerton, WA

This report is prepared exclusively for **Joe Smith** Inspected On: **06-05-2023**

Company Information Clearview Property Inspections 678-488-9479 jeff@clearviewproperty.biz www.clearviewproperty.biz Published Report

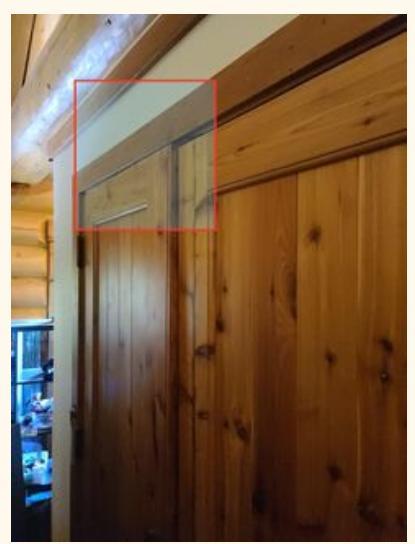
Adjust the hallway closet doors on the south side second floor

Hire a qualified general contactor to further evaluate and repair/adjust interior doors as needed for reliable performance.

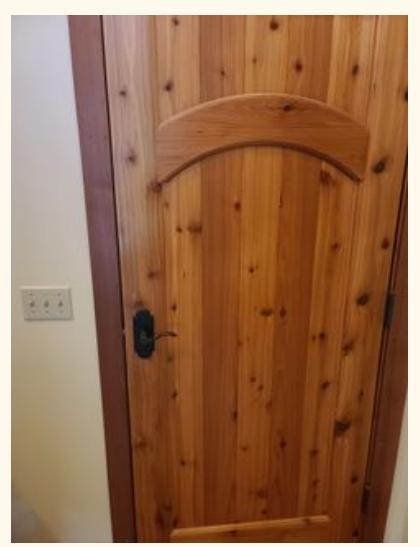
The door to the southeast bedroom is not latching and requires adjustment

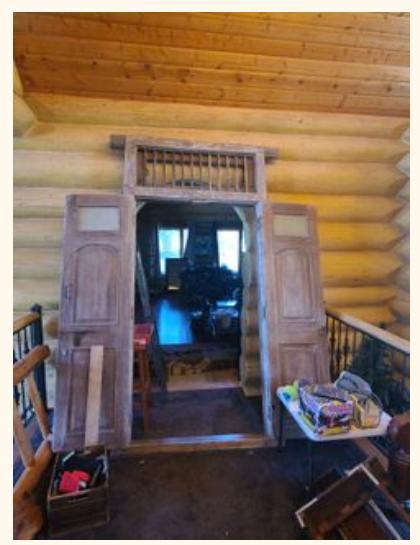
Complete installing the doors to the north bedroom

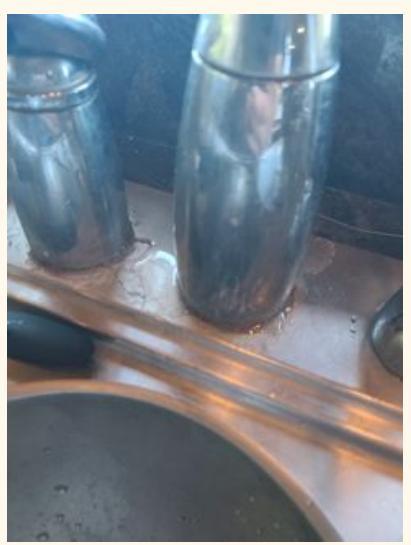
The kitchen sink faucet handle is leaking and needs to be repaired or replaced.

Water is seeping around the kitchen sink

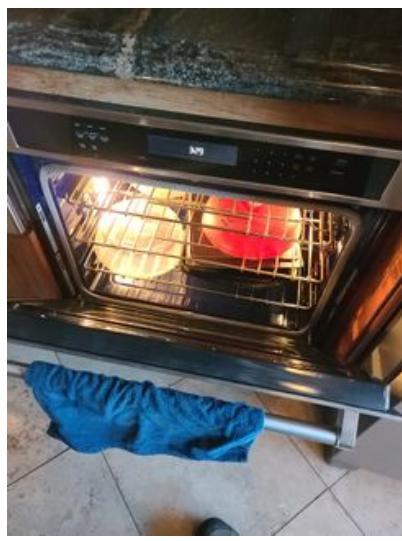
Note: I did not test the south oven as there were storage items in the oven

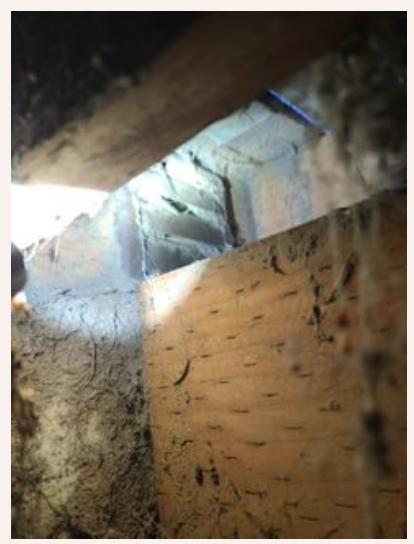
The dryer exhaust ductwork is dirty and needs to be cleaned for improved safety. This is important, regular maintenance to eliminate a potential fire hazard.

The dryer exhaust vent on the south side of the building under the deck needs to be cleaned.

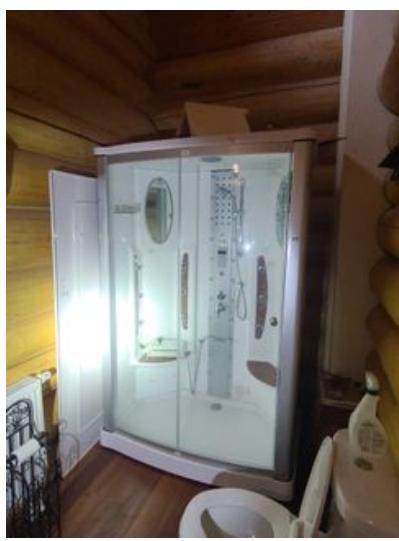
This shows the shower unit in the north guest bathroom

Have the shower further evaluated and installation completed by a qualified plumber.

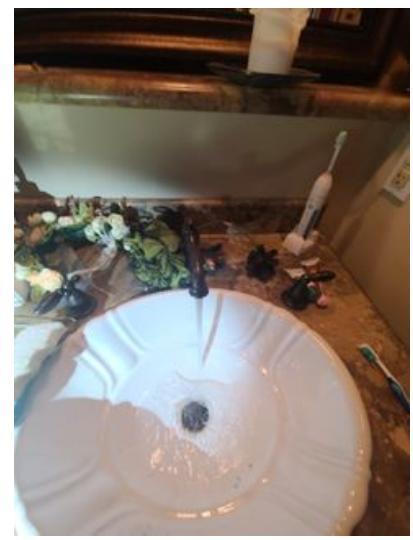
An inoperative sync stopper was noted at the right side main bath sink

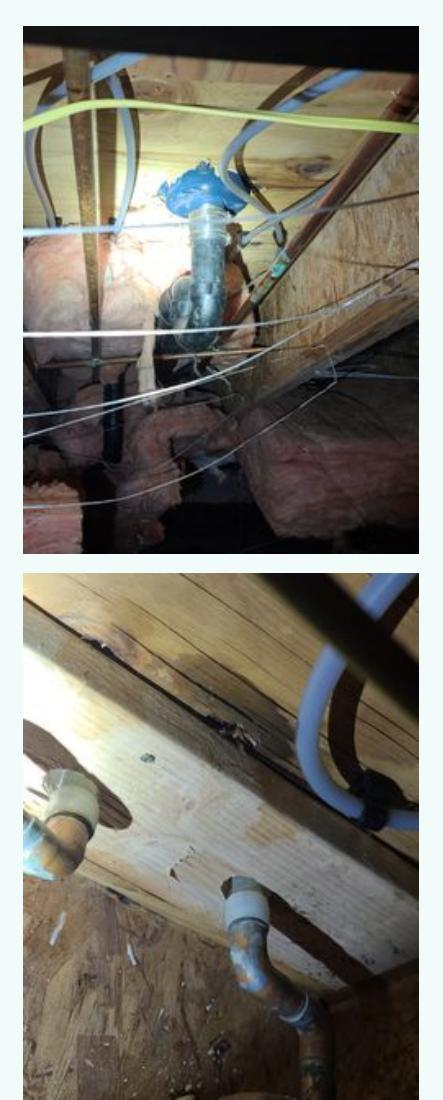
Water damaged plywood and water stains were noted below the main bath shower. This tested dry at the time of inspection. I suspect this is from a prior leak/failure of the main bath shower. The shower looked newer.

Rotten plywood was noted below the main bath shower. This was dry at the time of inspection but damaged plywood was noted.

Disclose any additional information about prior repairs.

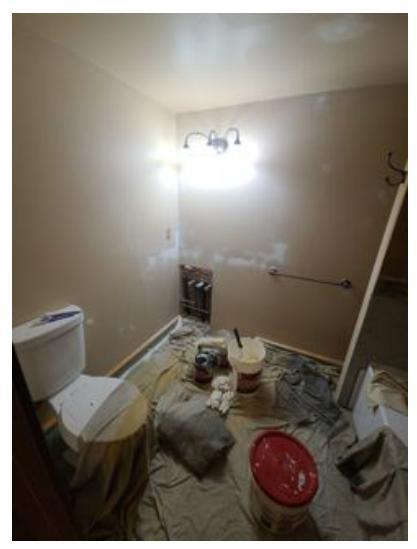
The south guest bathroom is under remodel at the time of inspection. Completely remodeling this bathroom as needed.

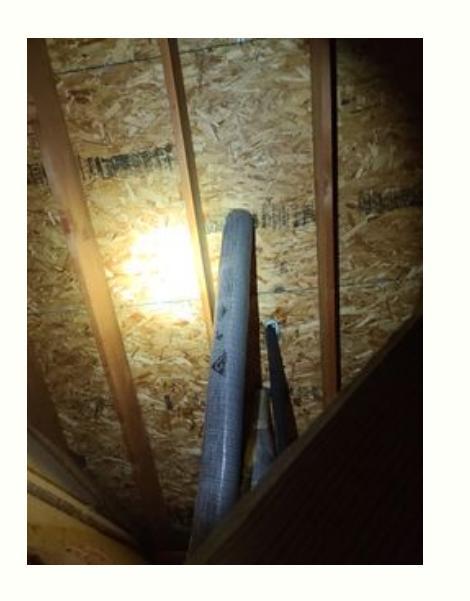
The accessible exhaust fan vents in the attic were noted to be correctly terminating to the exterior where visible.

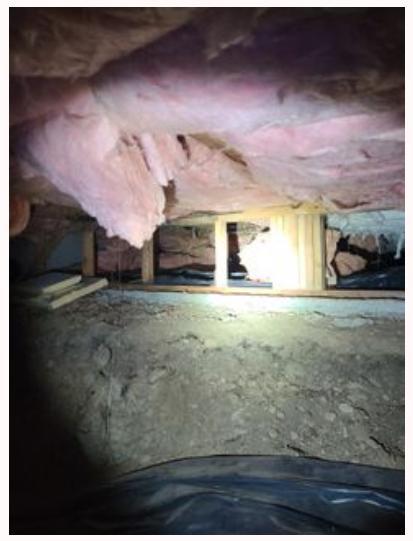
Adjust the plastic vapor barrier material so all exposed earth is covered.

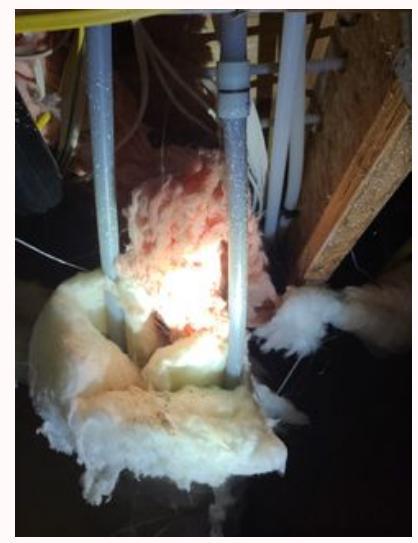
Pipe insulation is incomplete in the crawl space - be sure all pipes are insulated

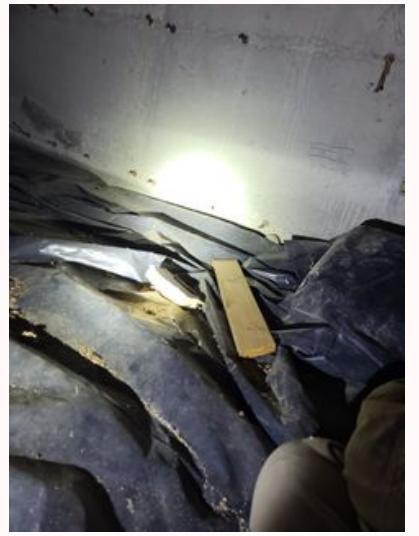
Remove all wood debris from the crawl space to eliminate conditions conducive to wood destroying organisms

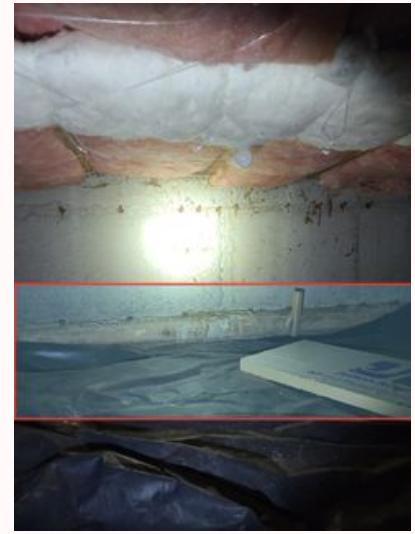
Strip off/remove all form wood in the crawl space to eliminate a condition conducive to wood destroying organisms

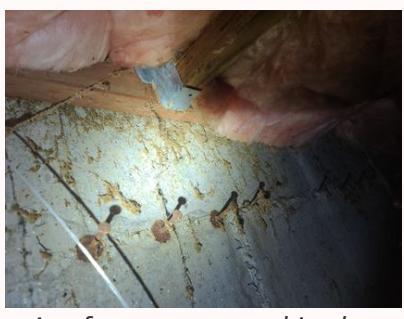
Ant frass was noted in the middle space. No ants were found. These look like from pavement ants. Clean and monitor.

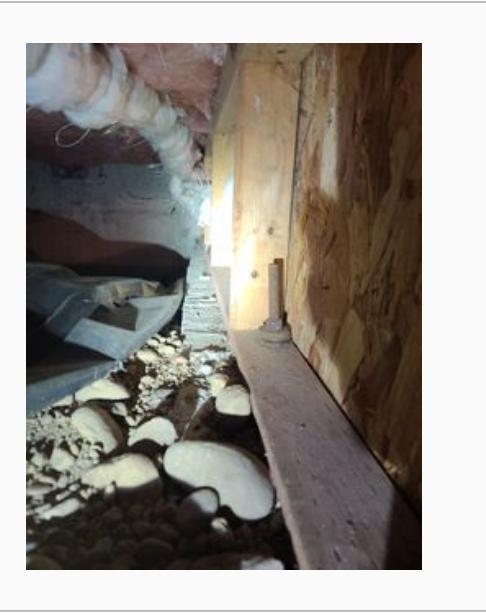
Signs of seismic protection were noted during the inspection. This inspection is not a cohesive analysis of seismic engineering, but I do look for signs of seismic protection.
